## BUREAU OF AIRCRAFT SAFETY INVESTIGATION PAKISTAN

### FINAL INVESTIGATION REPORT

#### ABORTED TAKE-OFF DUE TO ENGINE PROBLEM

| <b>Aircraft Type</b> | ATR 72-500 (72-212A) |

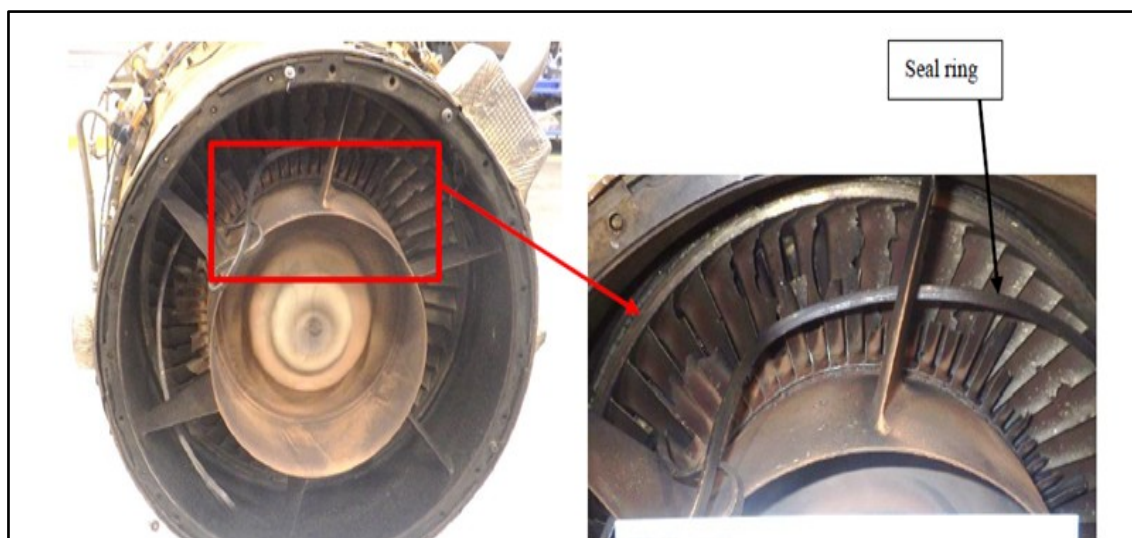
*Figure 1 Fracture 2<sup>nd</sup> Stage PT Blades at different height*

1.16.2.2. **Visual Examination** – Visual examination through the exhaust duct revealed fracture of all the 2<sup>nd</sup> stage PT blades at different heights. The seal ring was bent and out of its original position.

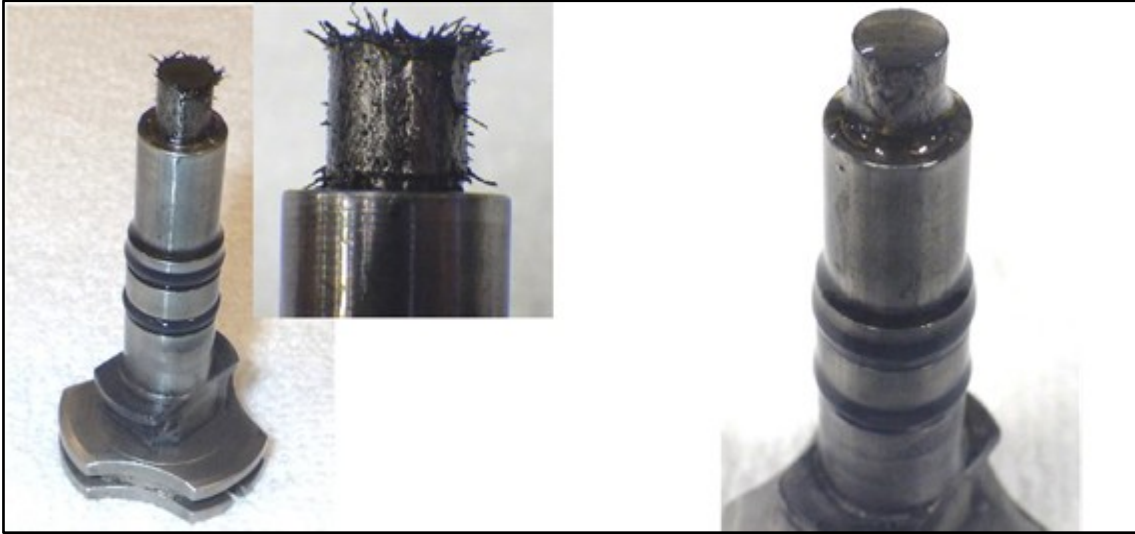
*Figure 2 TM MCD and RGB MCD*

1.16.2.3. The Turbo Machinery (TM) Magnetic Chip Detector (MCD) showed fuzz material and the Reduction Gearbox (RGB) MCD was in dirty condition.

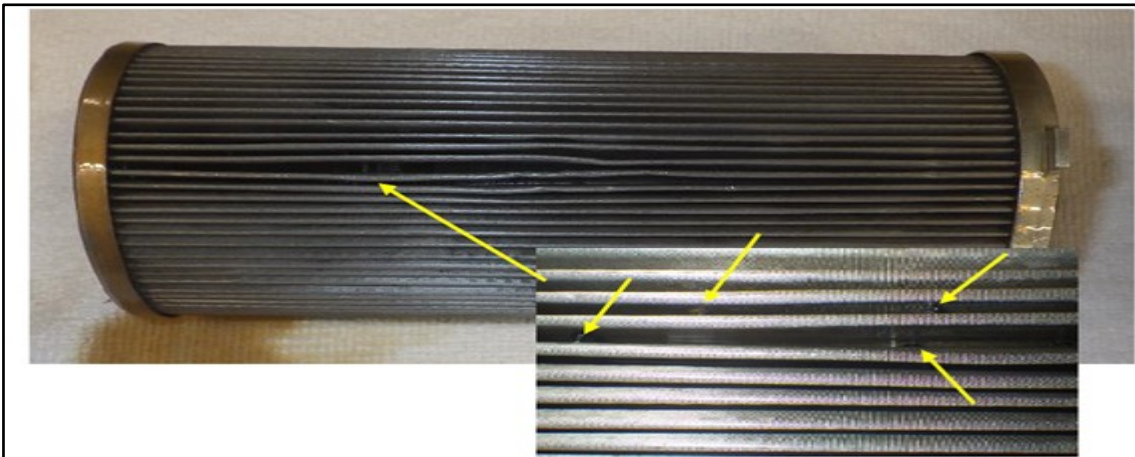
*Figure 3 TM Main Oil Filter*

1.16.2.4. The TM main oil filter showed entrapped debris (Yellow arrows).

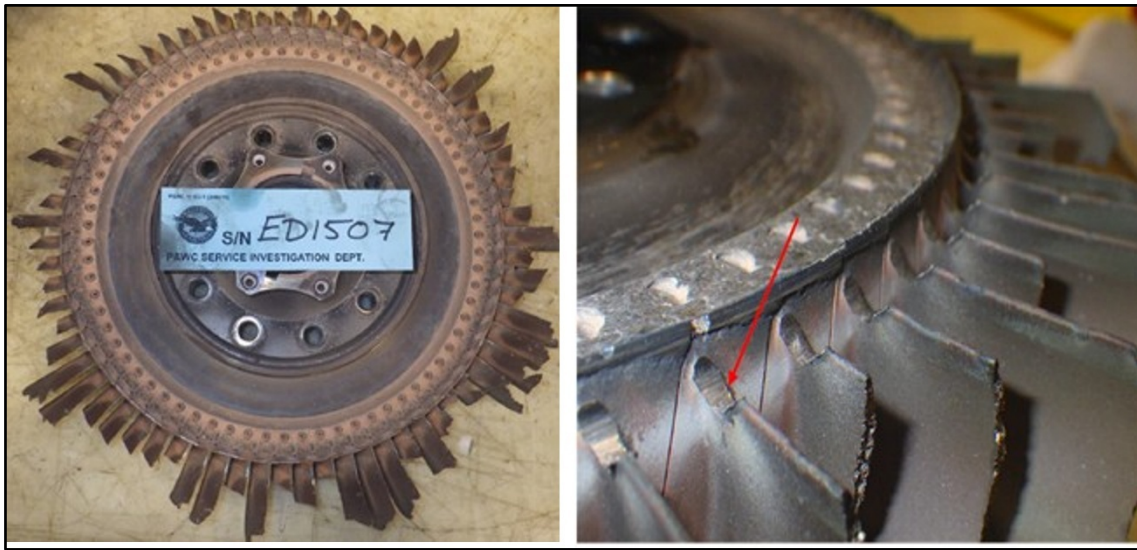
*Figure 4 2<sup>nd</sup> Stage PT Disc Assembly and Impact Disc*

1.16.2.5. Removal of the 2<sup>nd</sup> stage PT disk assembly showed that all the blades fractured at various height. The front face of the 2<sup>nd</sup> stage PT disk showed impact damages and rubbing on the platform. The root of the leading edge was machined/grooved by contact with the 2<sup>nd</sup> stage PT stator (red arrow).

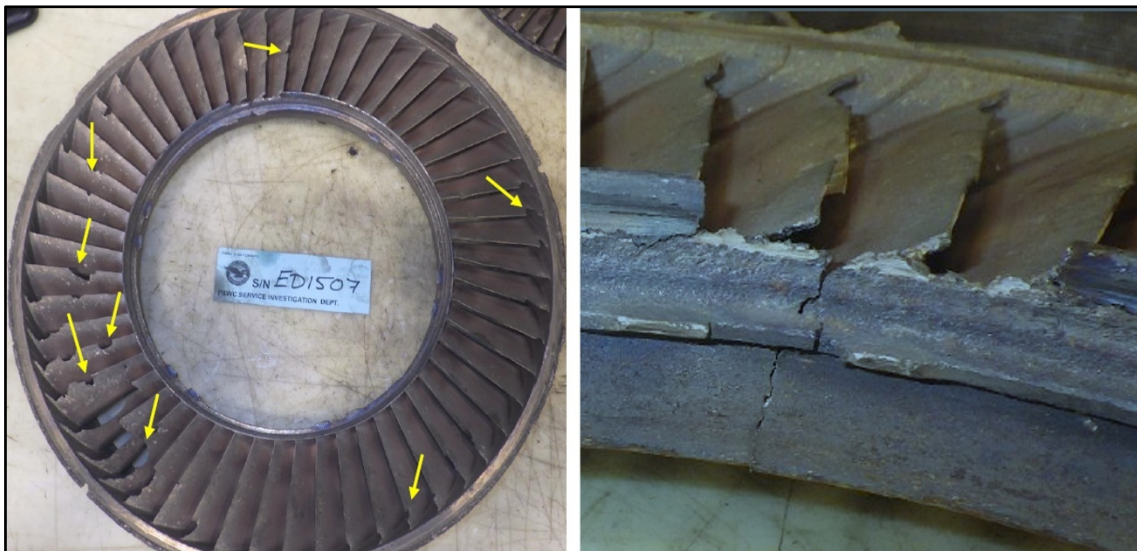
*Figure 5 2<sup>nd</sup> Stage PT Stator and Inner Ring*

1.16.2.6. The 2<sup>nd</sup> stage PT stator downstream side showed impact damages on the vanes (yellow arrows) and the inner ring was fractured and lost material due to contact with the 2<sup>nd</sup> stage PT disk assembly.

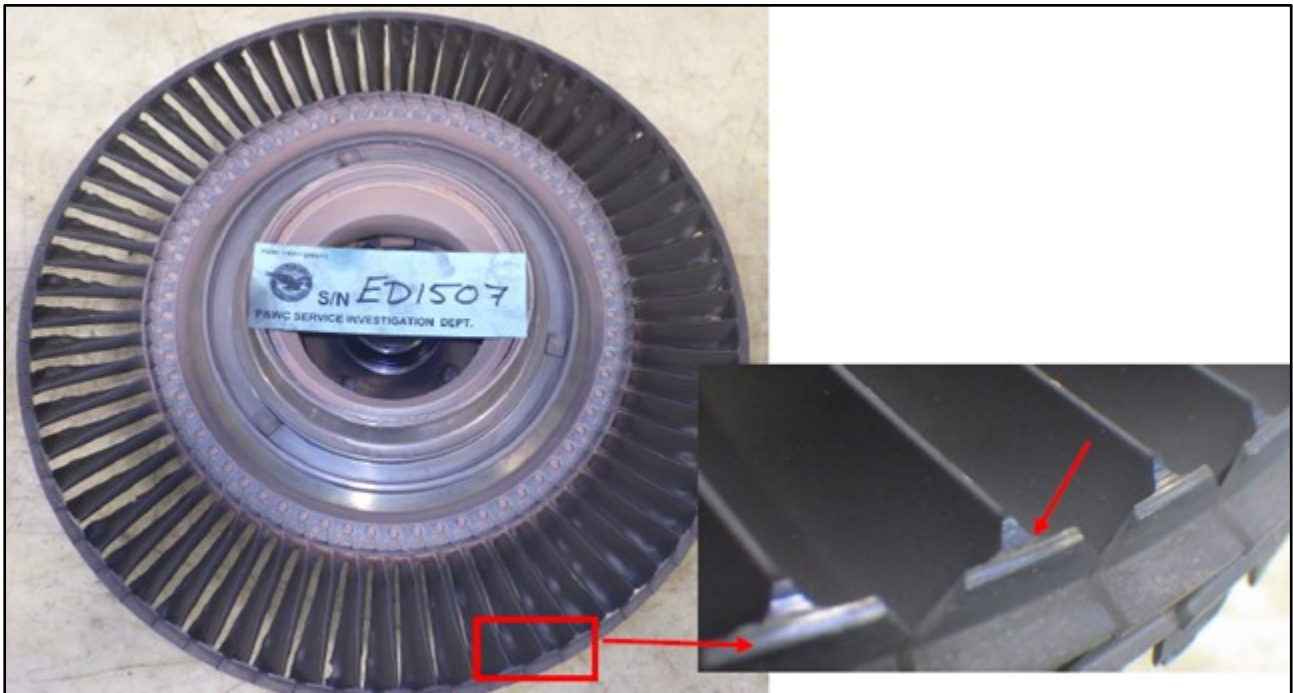
*Figure 6 1<sup>st</sup> Stage PT Blades*

1.16.2.7. The 1<sup>st</sup> stage PT blades showed impact damages on the trailing edge and rubbing at the Leading Edge (L/E) shrouds (red arrow).

2.2.2.1. The rubbing observed on the 1st stage & 2nd stage PT blades platforms, LP Impeller and PT Shaft were secondary due to the unbalance generated by the 2nd stage PT Blades fracture.

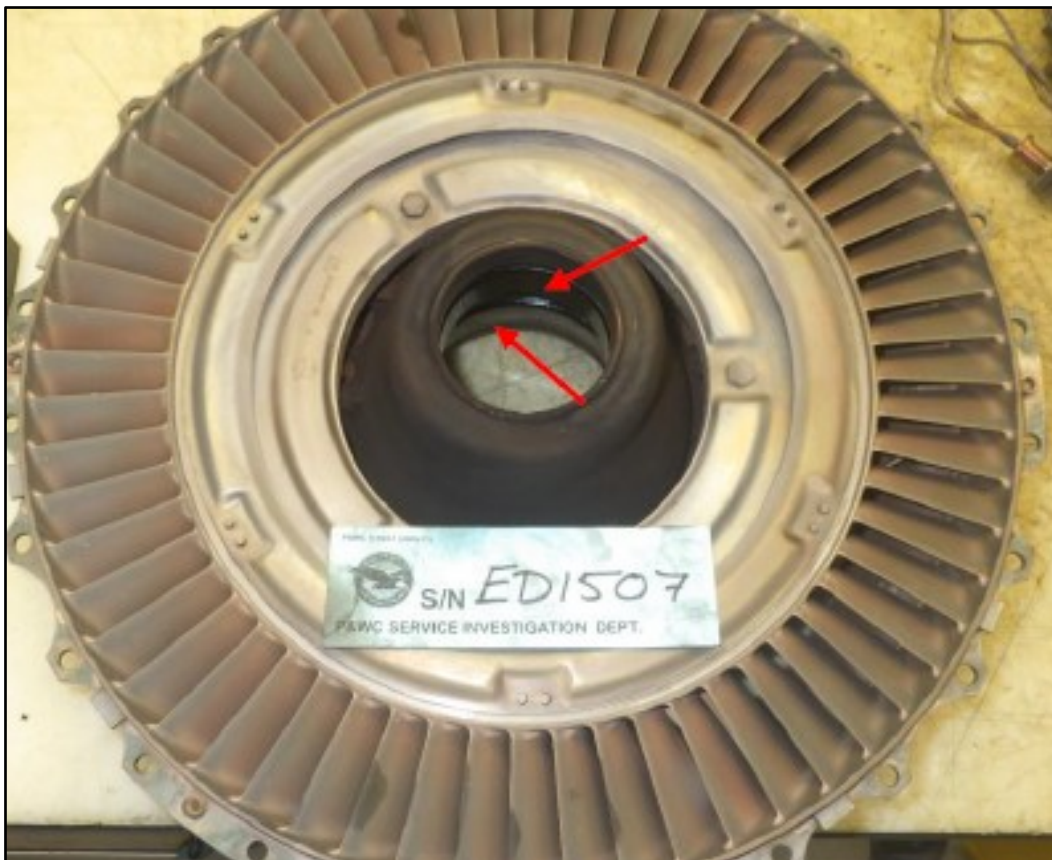
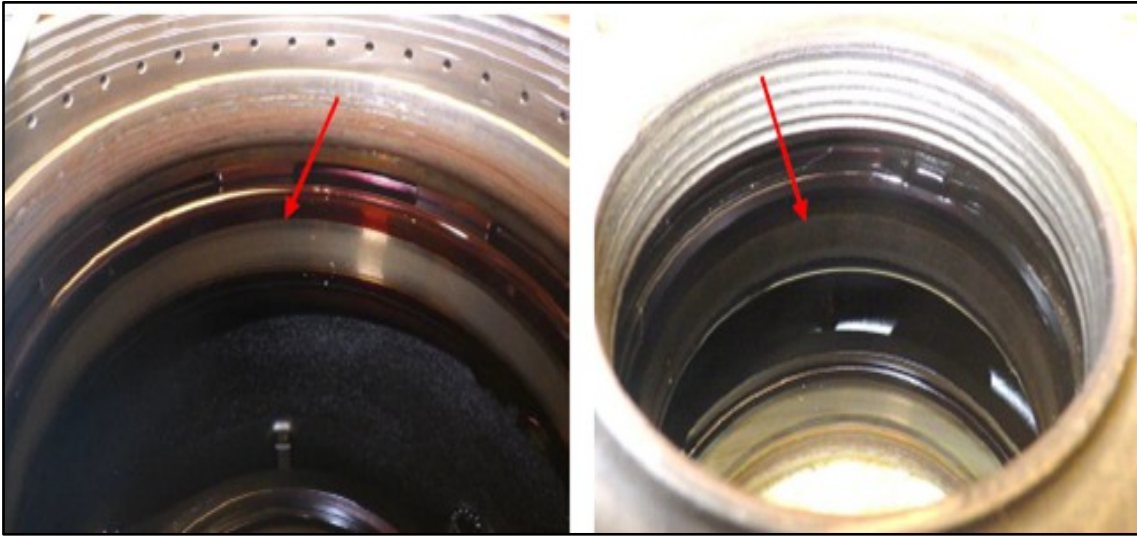
1.16.2.8. Removal of the 1<sup>st</sup> stage PT stator showed no damage on the No. 6 & 7 bearing outer race (red arrows).

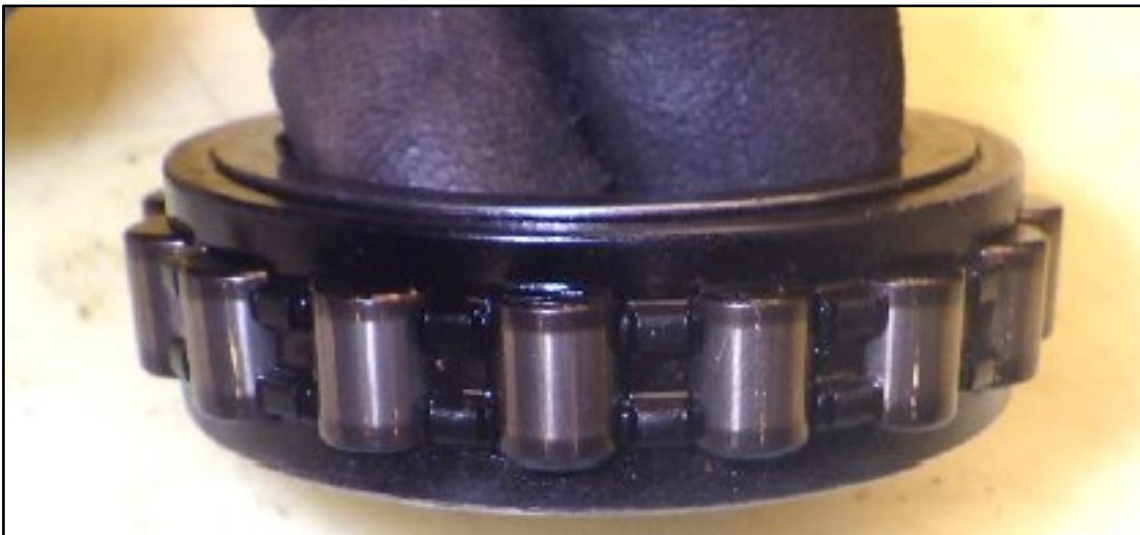
*Figure 9 No 7 Bearing Rollers*

1.16.2.9. No spalling was observed on the No. 7 bearing rollers.

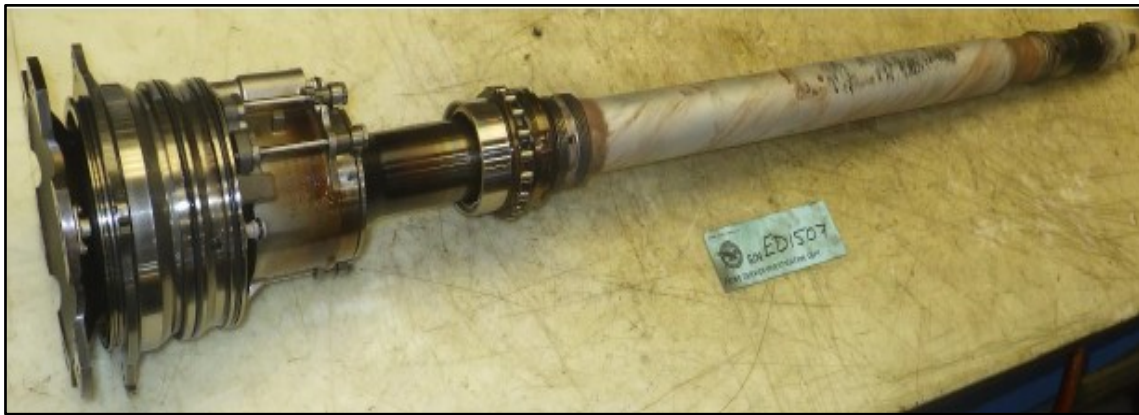
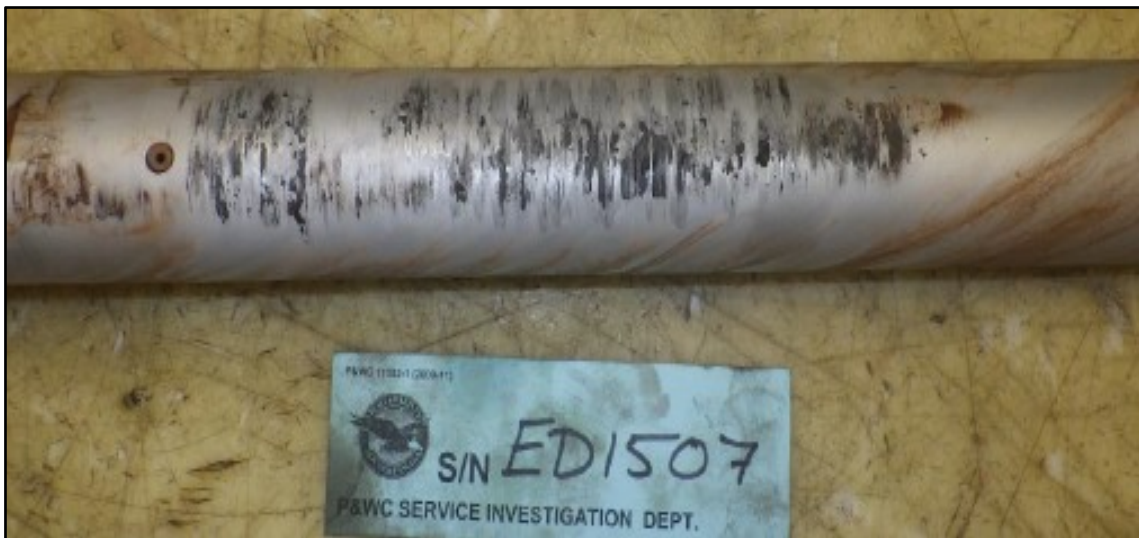
1.16.2.11. Removal of the PT shaft showed intershaft rubbing. No damage observed on the No. 2 bearing and the No. 1 bearing rotated freely.

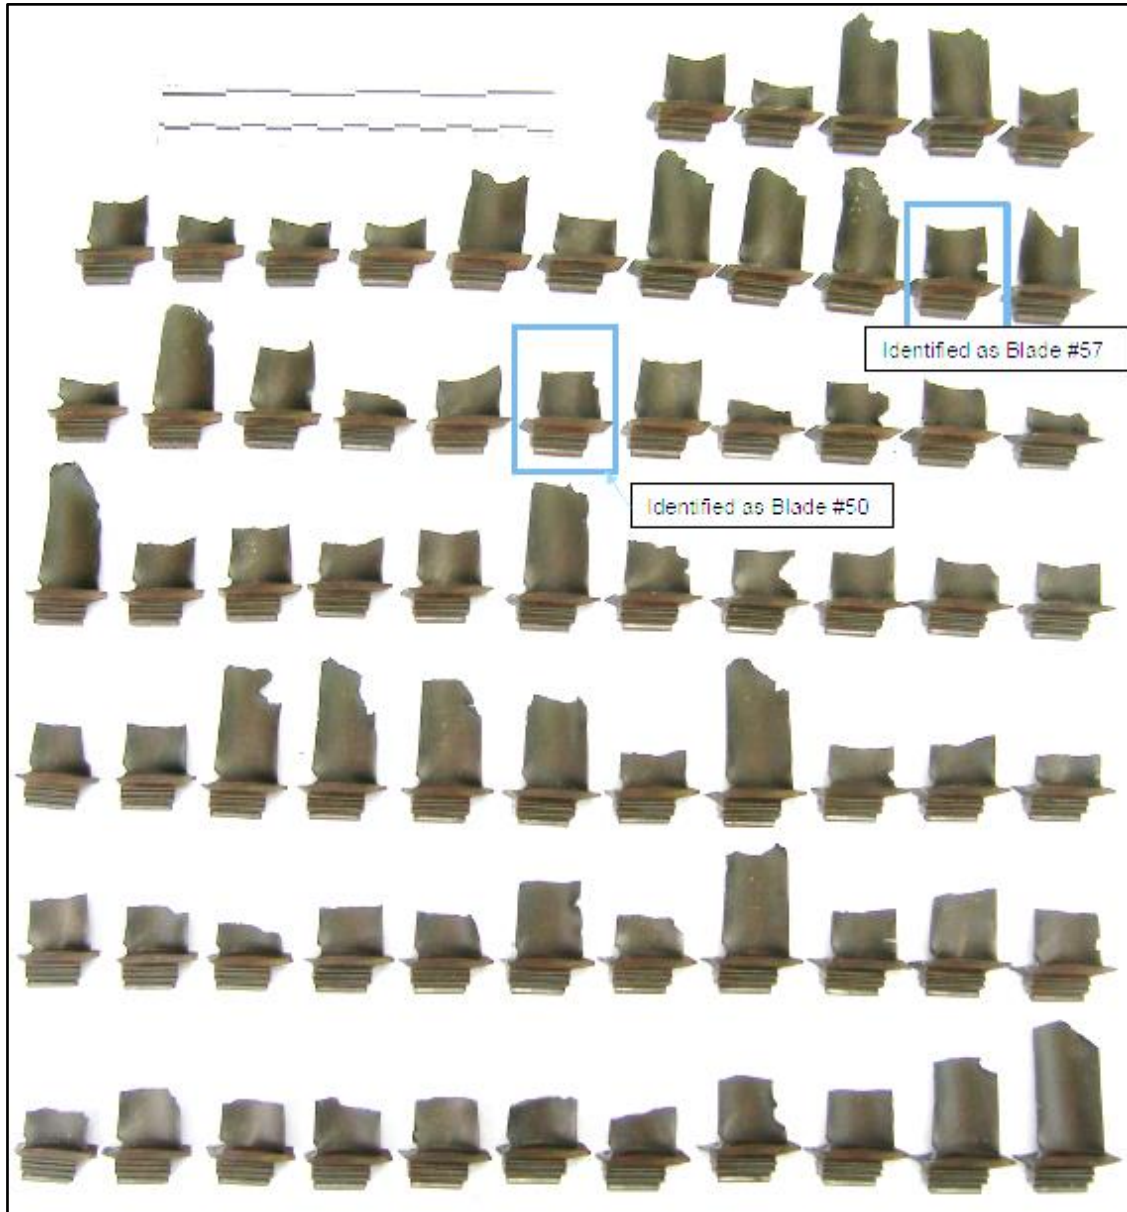
*Figure 13 2nd stage PT blades*

1.16.2.12.1. The 2<sup>nd</sup> stage PT blades were arbitrary numbered and the blade No. 50 & 57 were selected for analysis.

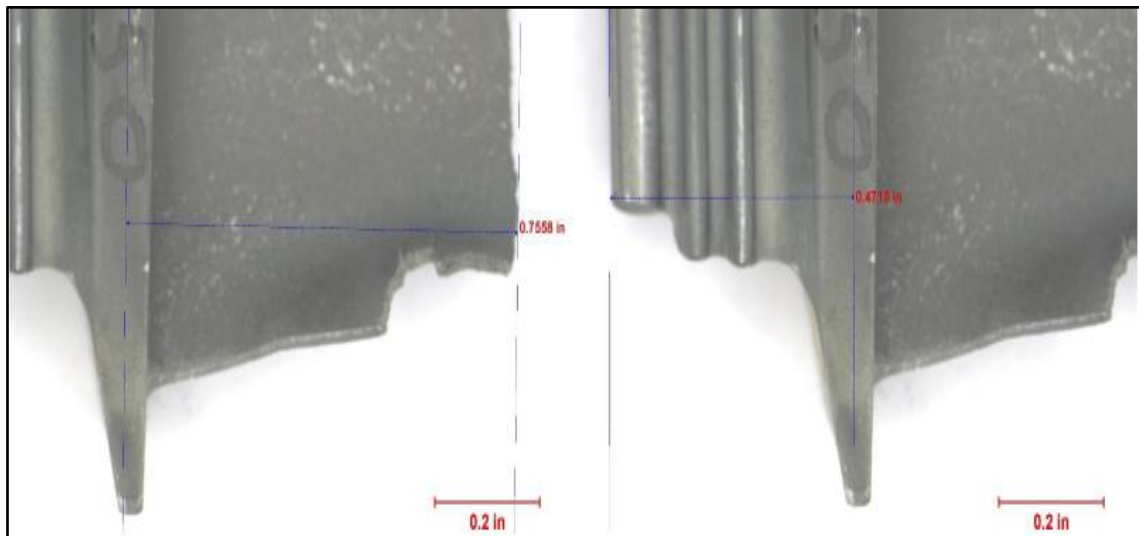
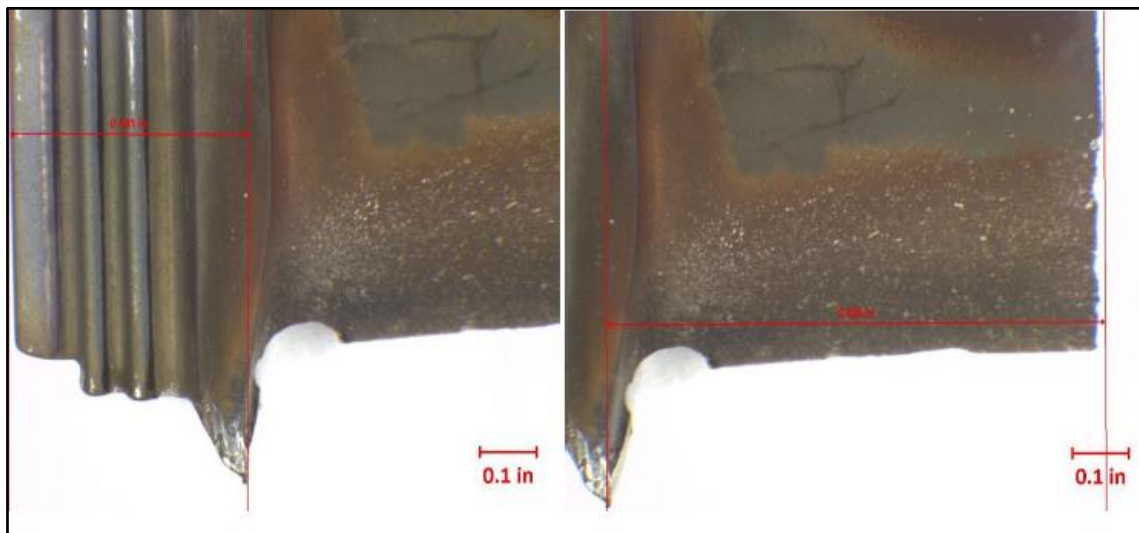
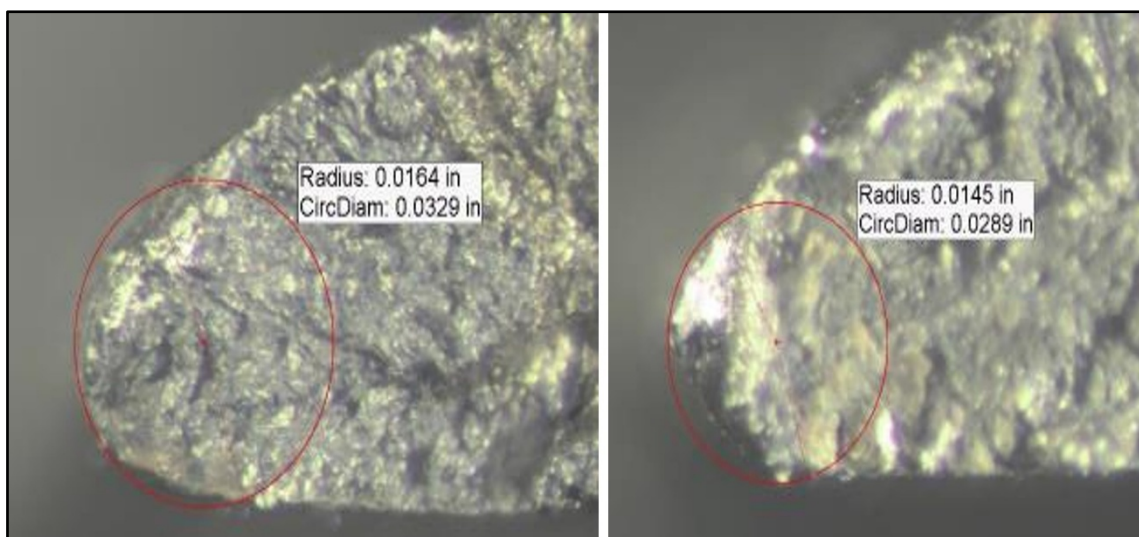
1.16.2.12.2. The 2<sup>nd</sup> stage PT blades No. 50 & No. 57 were fractured at 1.22" & 1.367" from the bottom of the root respectively. The L/E radius of the 2<sup>nd</sup> stage PT blades No. 50 & 57 were within drawing requirements.

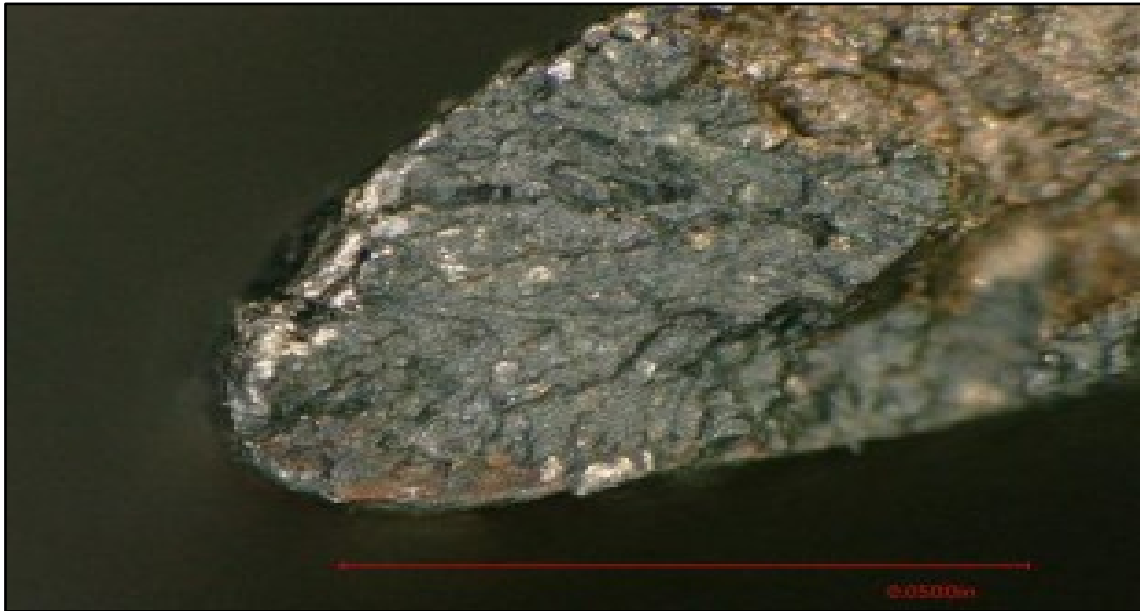
*Figure 17 Magnified view of the blade No. 50 fracture surface*

1.16.2.12.3. Magnified view of the blade No. 50 fracture surface revealed a dark grey color and smooth appearance at the L/E for approximately 0.050" into the blade. The smooth appearance at the L/E suggest a fatigue crack initiated from the L/E area and propagated throughout the trailing edge (T/E).

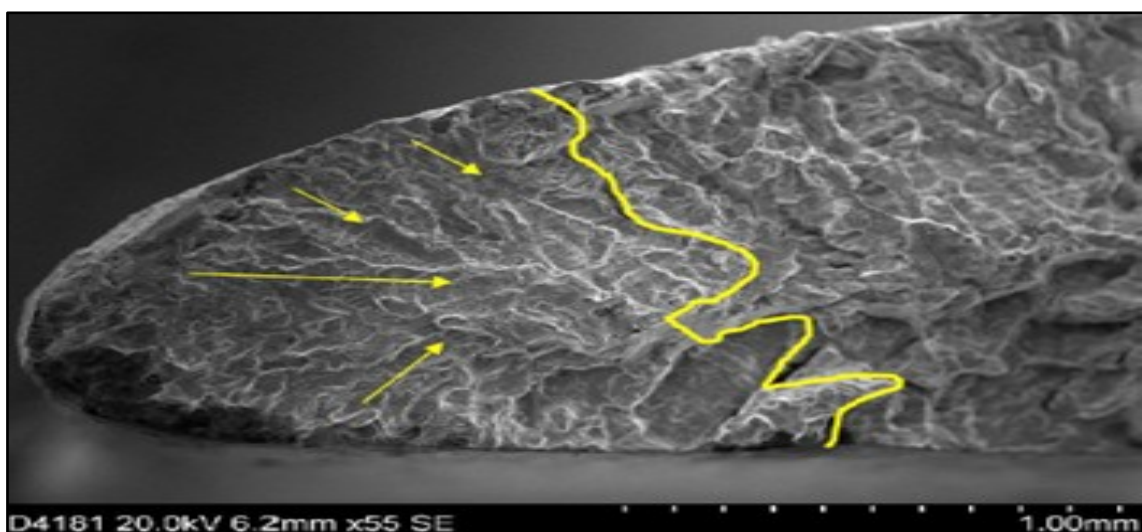
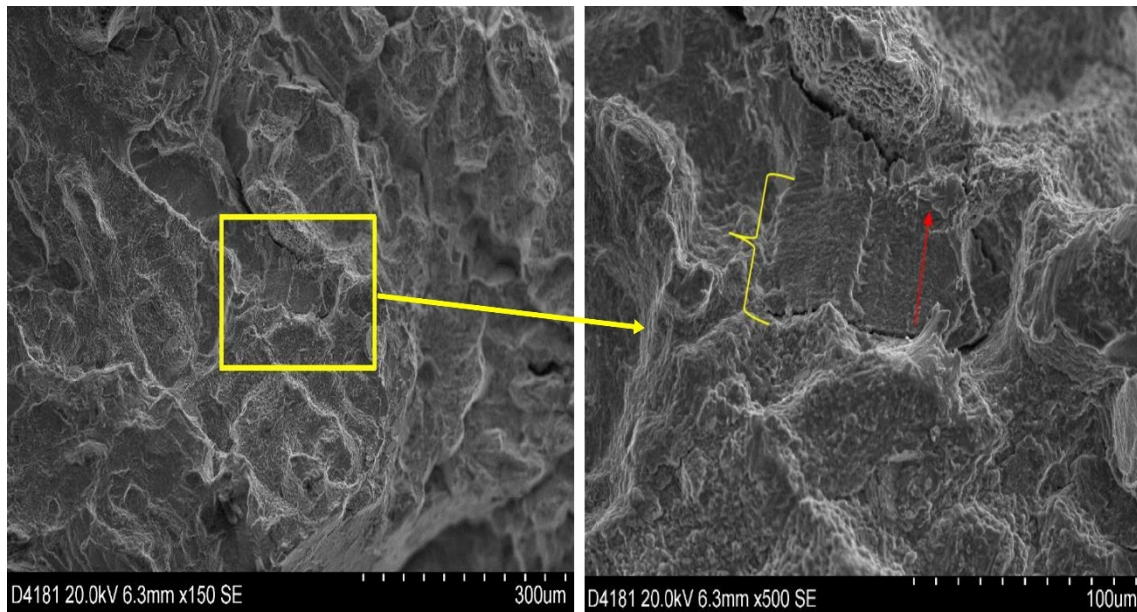
1.16.2.12.4. General Scanning Electron Microscope (SEM) view of the fracture surface of the 2<sup>nd</sup> stage PT blade No. 50 revealed flat facets consistent with fatigue crack propagation and intergranular topography. The yellow arrows showed the local fatigue crack propagation direction suggested by the observed river lines. The crack likely initiated at multiple locations along the leading edge. Higher magnification in the fatigue region showed evidence of fatigue striation (yellow bracket). The red arrow indicates the direction of crack propagation.

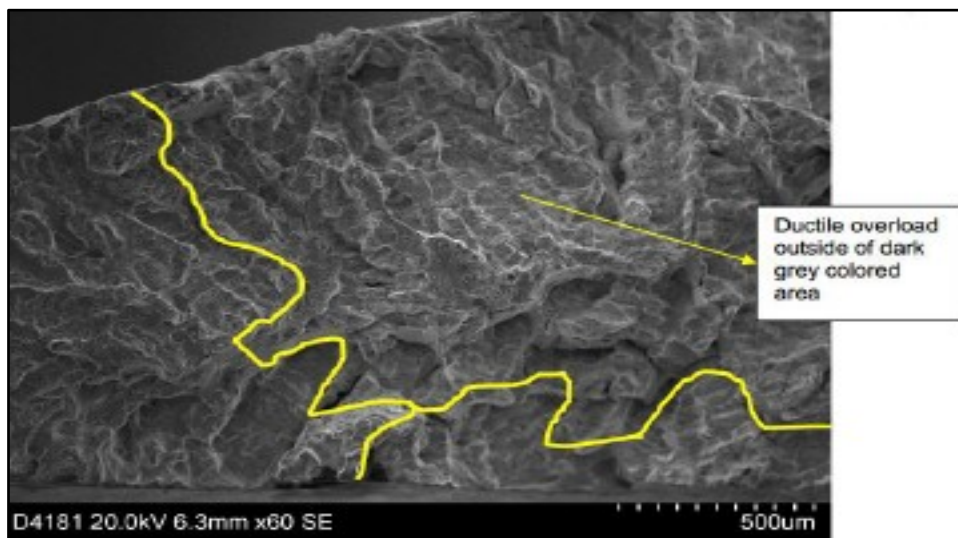
*Figure 20 Ductile Overload*

1.16.2.12.5. The fracture surface of the blade No. 50 outside the dark grey colour was identified as ductile overload.

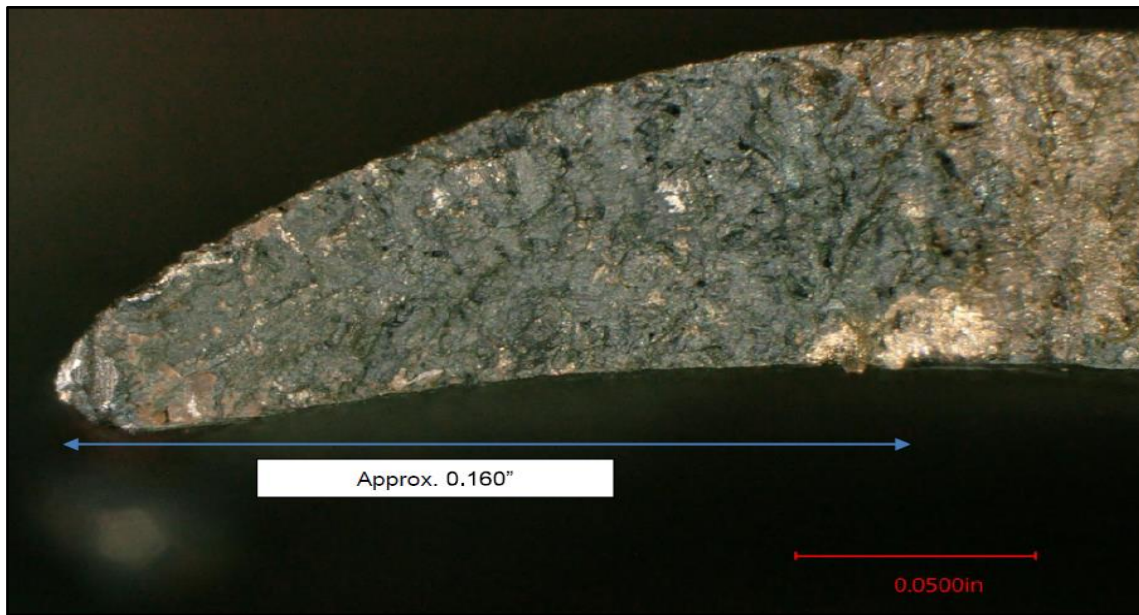
1.16.2.12.6. Magnified view of the 2<sup>nd</sup> stage PT blade No. 57 fracture surface revealed a dark grey color and smooth appearance at the L/E for approximately 0.160" into the blade. The smooth appearance at the L/E suggest a fatigue crack initiated from the L/E area and propagated throughout the T/E.

*Figure 21 Fatigue Crack Initiated from the L/E Area and Propagated Throughout the T/E*

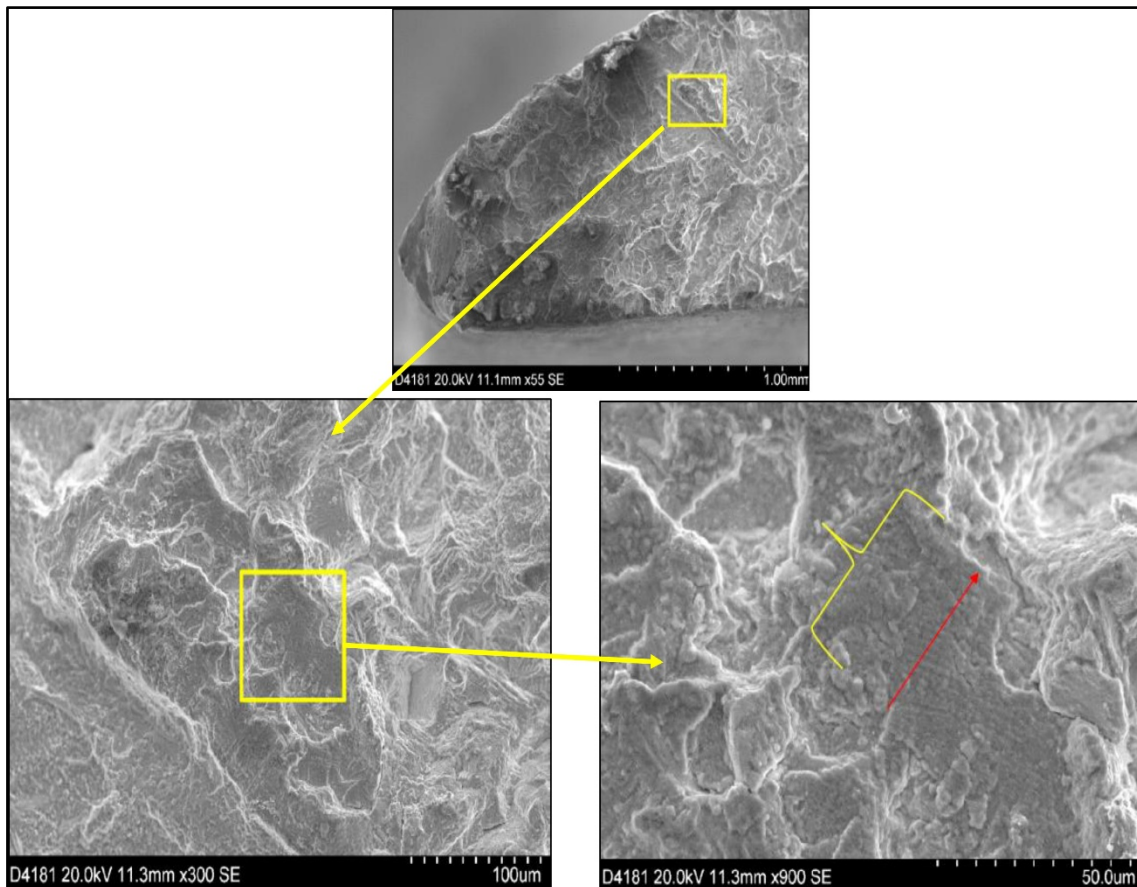
1.16.2.12.7. Higher magnification SEM view of the 2<sup>nd</sup> stage PT blade No 57 in the dark grey coloured area showed evidence of fatigue striation (yellow bracket. The red arrow indicates the direction of crack propagation.

*Figure 22 Fatigue Striation and Direction of Crack Propagation*

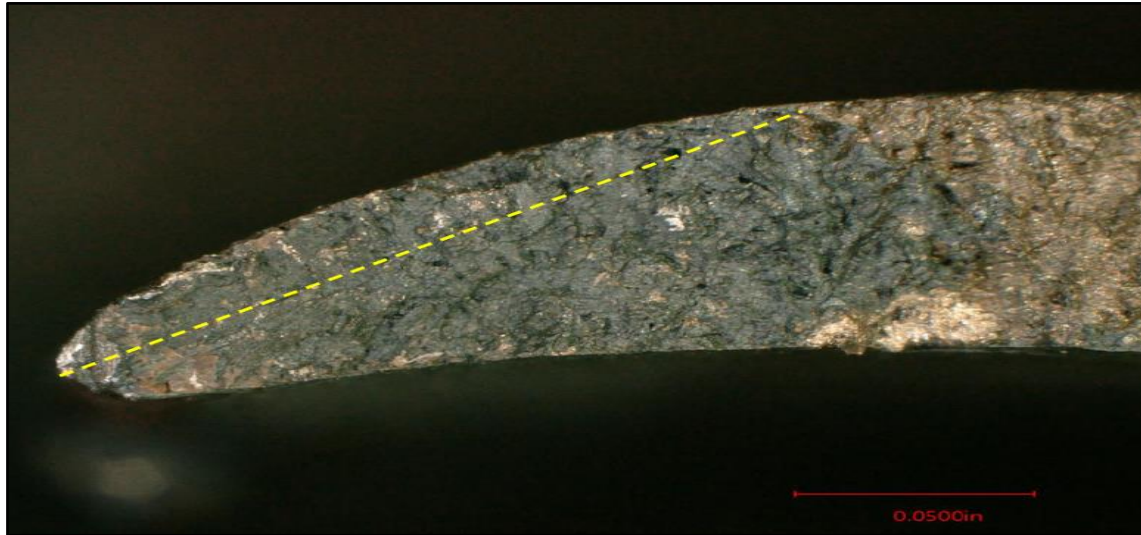
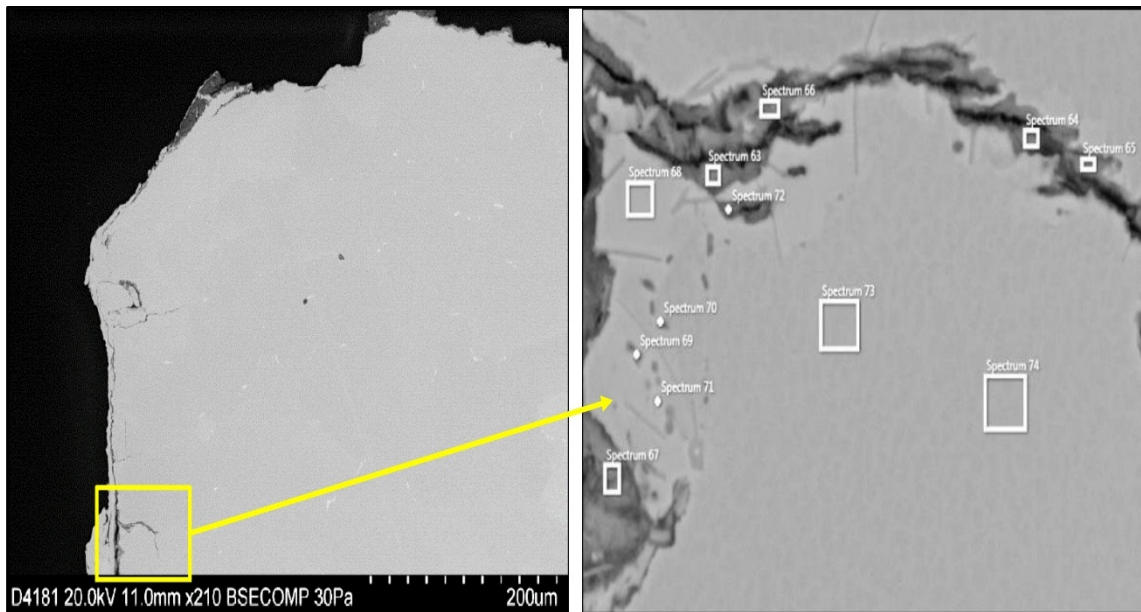
1.16.2.12.8. Metallographic cross section of the 2<sup>nd</sup> stage PT blade No. 57 through the L/E and fracture surface origin area showed secondary parallel cracks initiation from the L/E

and extending into the blade (yellow rectangle). Energy Dispersive Spectrum (EDS) analyses using standardless and semi-quantitative method of the cross section along the L/E showed an elevated level of Sulphur and Chromium, indicative of Type I hot corrosion.

2.2.1.1. Failure mode analysis of the selected blades indicated that the cracks observed on the Leading Edge (L/E) of the 2nd stage PT Blades occurred by sulphidation Type I hot corrosion.

2.2.1.2. The 2nd stage PT Blade fracture initiated from cracks at the L/E and propagated by fatigue up to final rupture by overload.

| 4.1.1. | |
|---|---|
| <b>Recommendation</b> | OEM (Pratt & Whitney, Canada) should continue to enhance the corrosion resistance and durability of second-stage Power Turbine (PT2) blades installed on PW127 series engines through improved coating systems and blade design modifications to mitigate sulphidation-induced hot corrosion and associated fatigue cracking |
