BUREAU OF AIRCRAFT SAFETY INVESTIGATION PAKISTAN

FINAL INVESTIGATION REPORT

IN-FLIGHT ENGINE SHUTDOWN HPT STAGE 1 BLADE FRACTURE DUE TO SPLCF / CREEP INTERACTION

Aircraft Type	Airbus A321-251NX
Registration	AP-BOD
Operator	Airblue Limited
Flight	ABQ207, Islamabad (OPIS) to Karachi (OPKC)
Date of Occurrence	30 October, 2023
Location	Approx 12 NM west of Islamabad International Airport (OPIS)
Classification	Serious Incident – In-Flight Engine Shutdown (IFSD)
Report Status	Final Investigation Report
Report Reference	HQ BASIP/1000/454/Inv
Date of Report	30 April, 2026

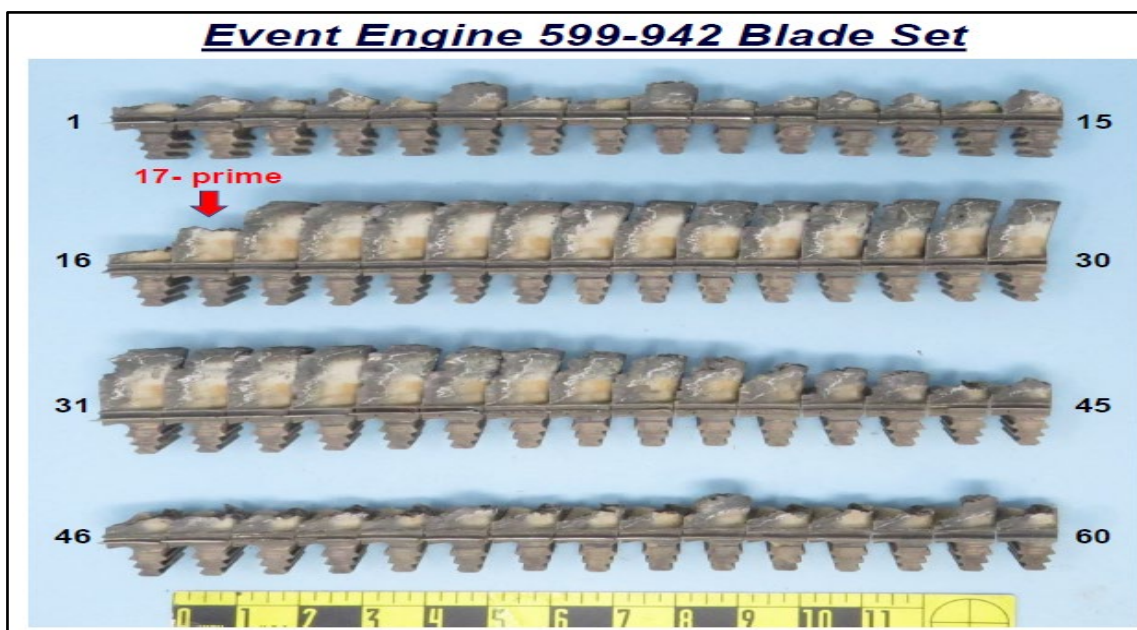
Figure 1 Blades

1.16.3.7. This overload liberated the outer airfoil span, which then overstressed and damaged the remaining 41 blades in the set.

1.16.3.7.1. Overall image of the submitted HPT stage 1 blades from 599-942 in the as-received condition. Blade 17 was consistent with being the prime blade that fractured at the mid-span, resulting in the liberation of the airfoil outer span which then overstressed the following 41 blades.

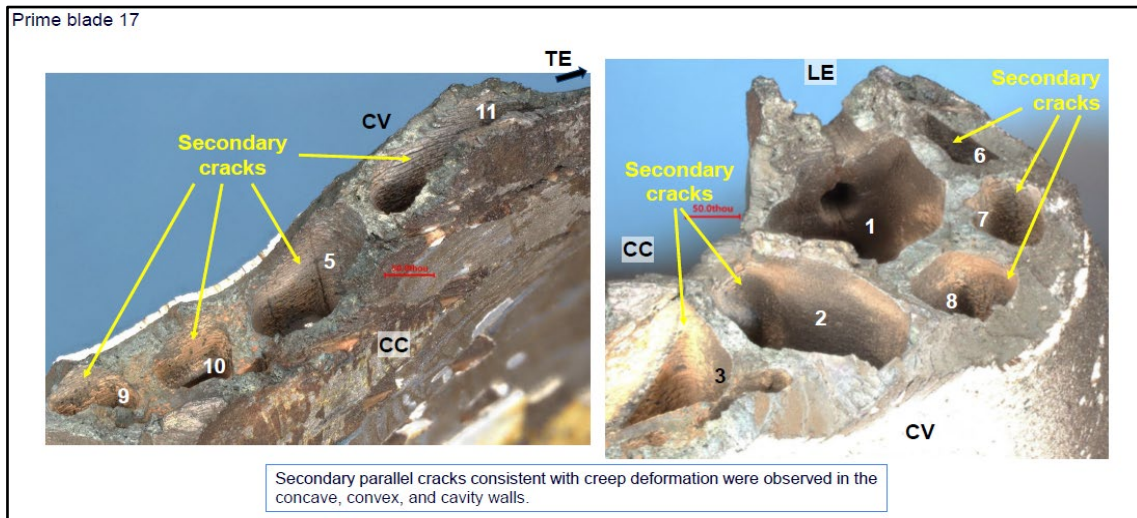
Figure 2 Creep-related parallel secondary cracks on blade walls

1.16.3.7.2.3. Parallel secondary cracks consistent with creep deformation observed on concave, convex and cavity walls.

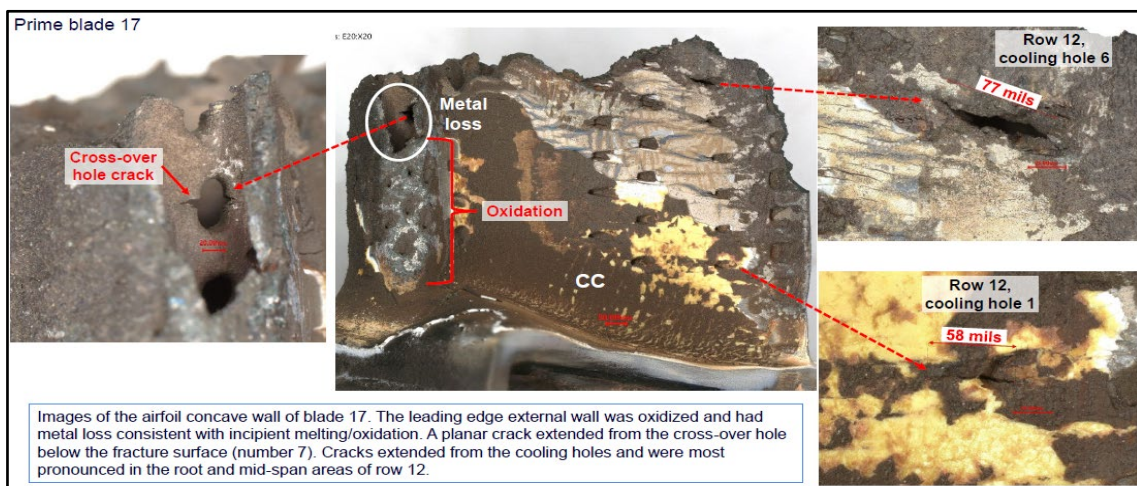
Figure 3 Airfoil Concave Wall of Blade 17

1.16.3.7.2.4. Leading-edge wall: heavy oxidation, incipient melting/oxidation, metal loss.

1.16.3.7.2.5. Cross-over hole crack and cooling-hole cracks most pronounced in root and mid-span (up to 77 mils metal loss at Row 12 hole 6).

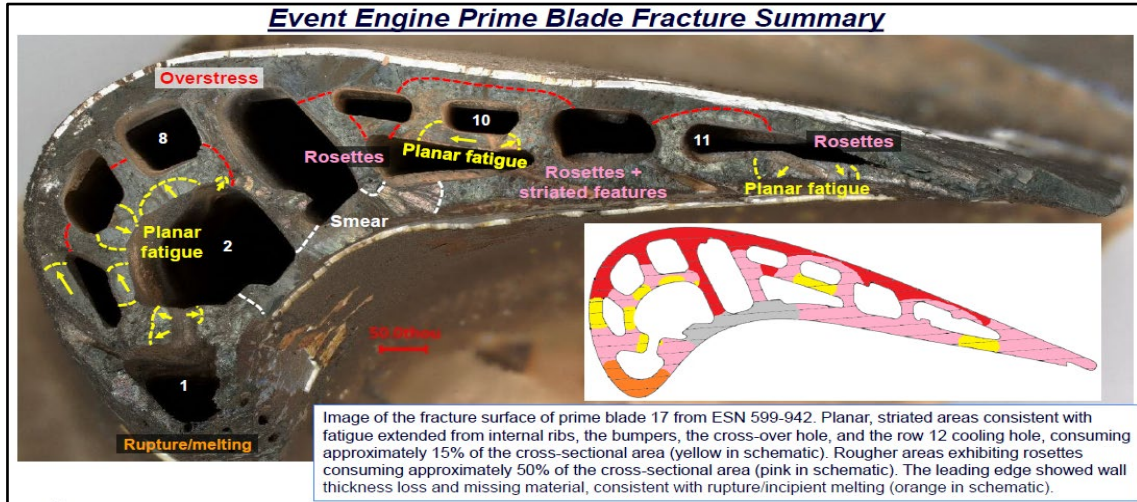
Figure 4 Blade Fracture Summary

1.16.3.7.3.2. **Pink: rosette + rougher fatigue (~50 % area).** Rougher areas exhibiting rosettes consuming approximately 50% of the cross-sectional area

1.16.3.7.3.3. **Orange: rupture/incipient melting at leading edge (~35 % area).** The leading edge showed wall thickness loss and missing material, consistent with rupture/incipient melting

2.2.2.1.2. Fracture Surface Composition: Analysis of the prime blade fracture surface identified as Planar/striated fatigue features, Rosette formations with rougher fatigue features & rupture and incipient melting at the leading edge, indicating severe thermal exposure with metal loss.

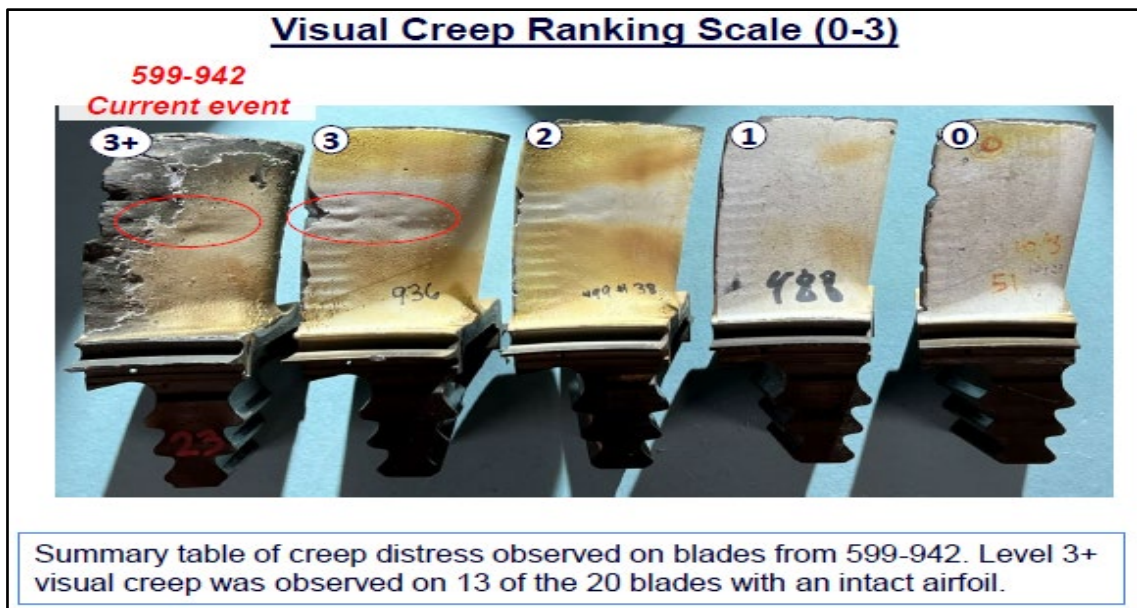
Figure 5 Creep Distress observed on Blades

1.16.3.7.4.4. Level 3+ creep observed on 13 of 20 blades examined. Multiple blades showed 3+ distress with radial growth >60 mils.

2.2.2.1.5. Creep Ranking: Visual creep ranking (0–3 scale) of the intact airfoils from ESN 599-942 revealed Level 3+ creep on 13 of 20 blades examined, with multiple blades showing >60 mils radial growth. This is consistent with advanced creep degradation across the HPT Stage 1 disc.

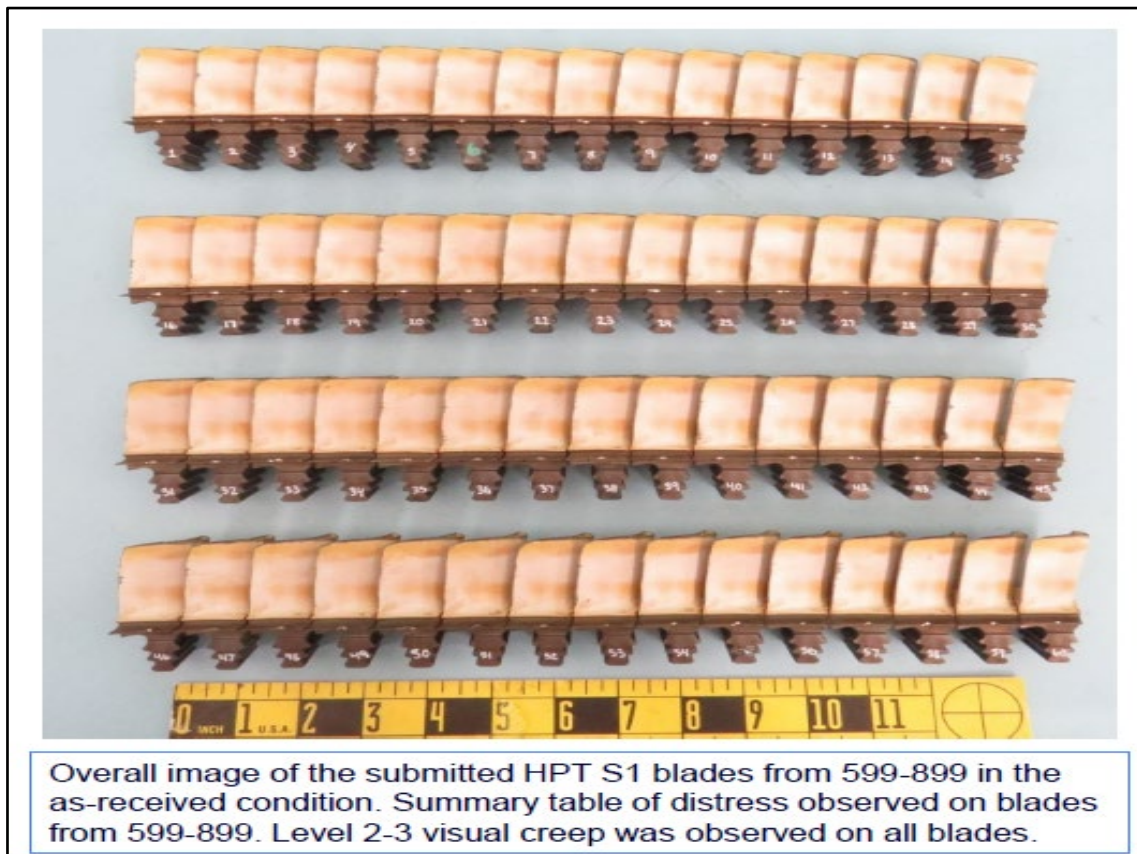
Figure 6 Level 2–3 visual creep distress

1.16.3.8.1. All 60 blades displayed Level 2–3 visual creep.

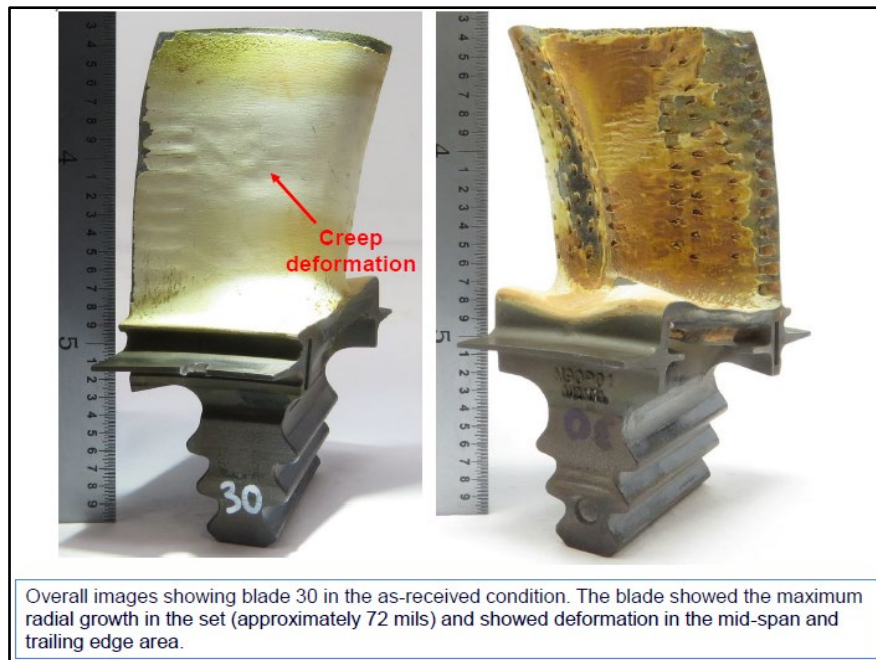
Figure 7 Maximum Radial Growth and Deformation in the mid-span

1.16.3.8.2. Maximum radial growth: 72.3 mils (blade 30).

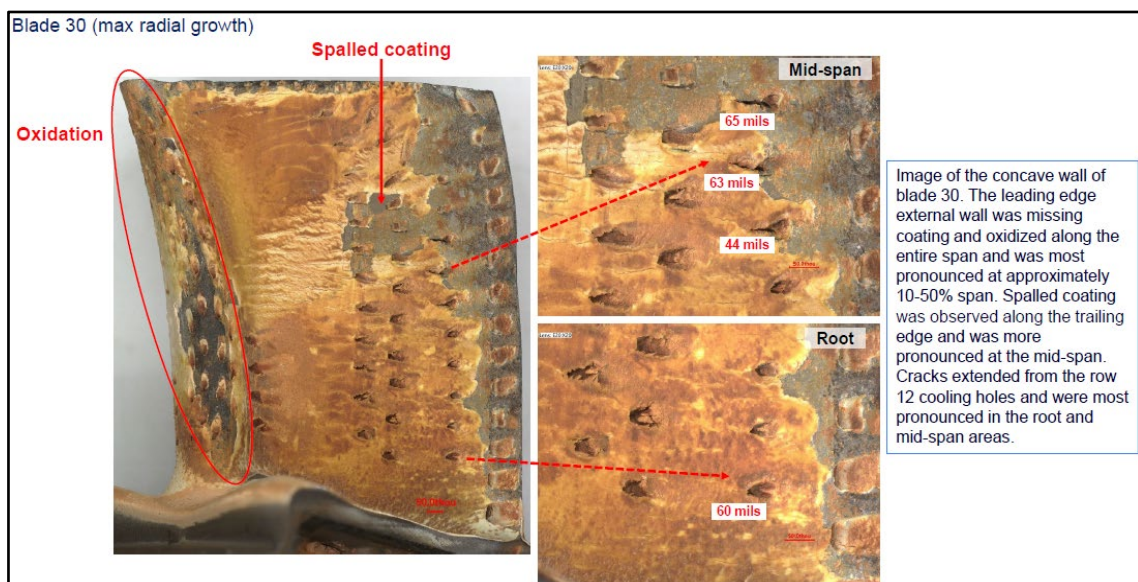
Figure 8 Blade 30: Creep deformation, TBC spallation, severe leading-edge oxidation

1.16.3.8.3. Blade 30 exhibited pronounced mid-span and trailing-edge creep deformation, spalled TBC, and heavy oxidation on the leading-edge external wall (most severe at 10 – 50 % span).

- 2.3.2.6. Selected highest radial growth values: Blade 30 (72.3 mils), Blade 57 (62.6 mils), Blade 58 (60.9 mils), Blade 6 (60.5 mils).
- 2.3.2.7. Blade 30 exhibited pronounced mid-span and trailing-edge creep deformation, spalled TBC, and heavy oxidation on the leading-edge external wall, most severe between 10–50% span.
