FINAL INVESTIGATION REPORT

ENGINE NO. 2 INFLIGHT SHUTDOWN (IFSD)

QATAR AIRWAYS

FLT QTR-6J, B-777-3DZ(ER) AIRCRAFT, REG NO A7-BEA

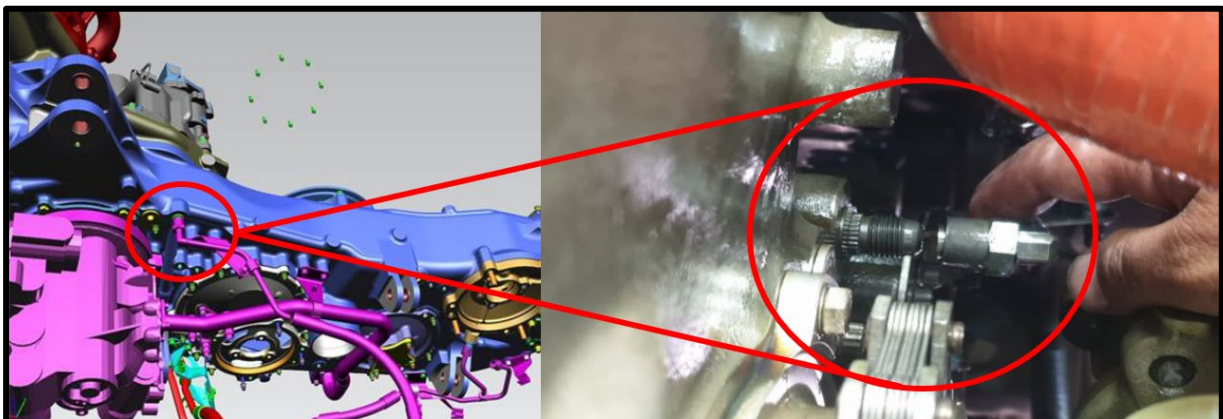
Figure 1 On-ground inspection found loose AGB oil Nipple

- 3.1.5. On-ground inspection identified a **loose AGB oil nipple connection**. Visual examination indicated oil staining around the interface.
- 3.1.6. The **mechanical failure originated within the AGB oil nipple assembly**, which connects the oil system to the gearbox housing.

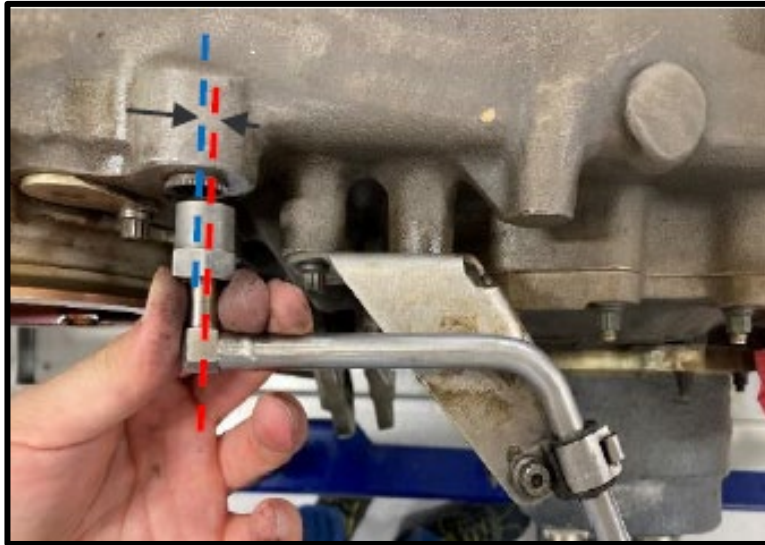
2.3.2.2. Following the Incident, the AGB module was shipped to GE Aviation Wales for detailed teardown and metallurgical assessment. Visual examination revealed that the **oil nipple hole was misaligned with the connected oil supply tube**, evidenced by clamp marks that did not correspond to the nipple’s orientation.

Figure 2 Oil Tube Misalignment 1/2

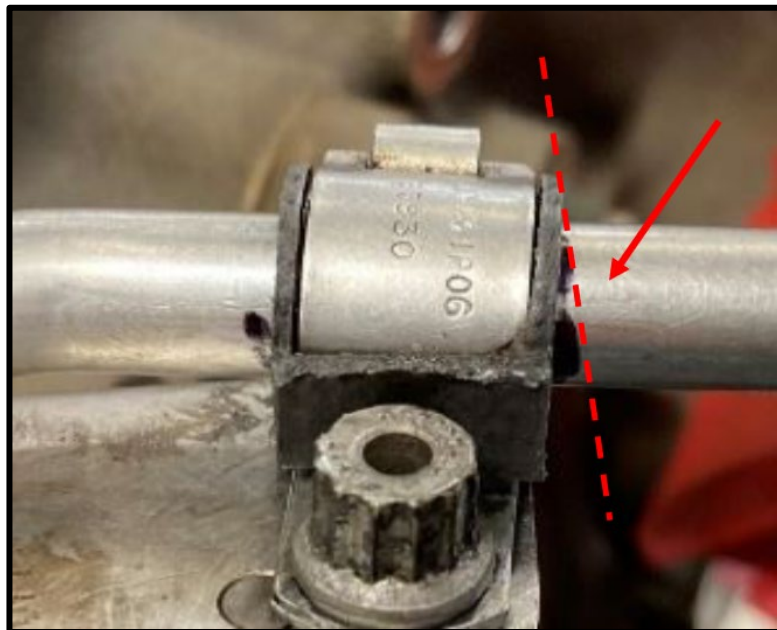
Figure 3 Oil Tube Misalignment 2/2

3.2.8. Misalignment of the oil supply tube increasing mechanical stresses and accelerating thread wear.

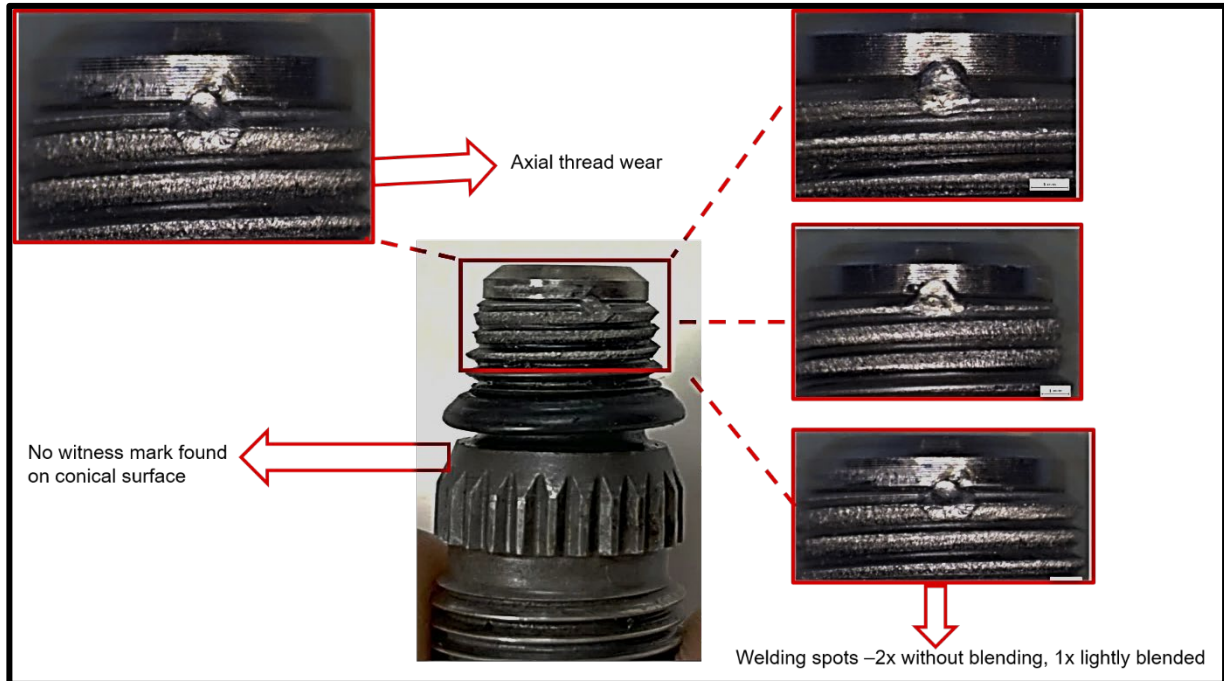
2.3.2.3. Severe thread damage was noted on both the nipple and the AGB housing, with axial wear visible through the full 360 degrees of thread contact.

Figure 4 Axial thread wear and welding spots

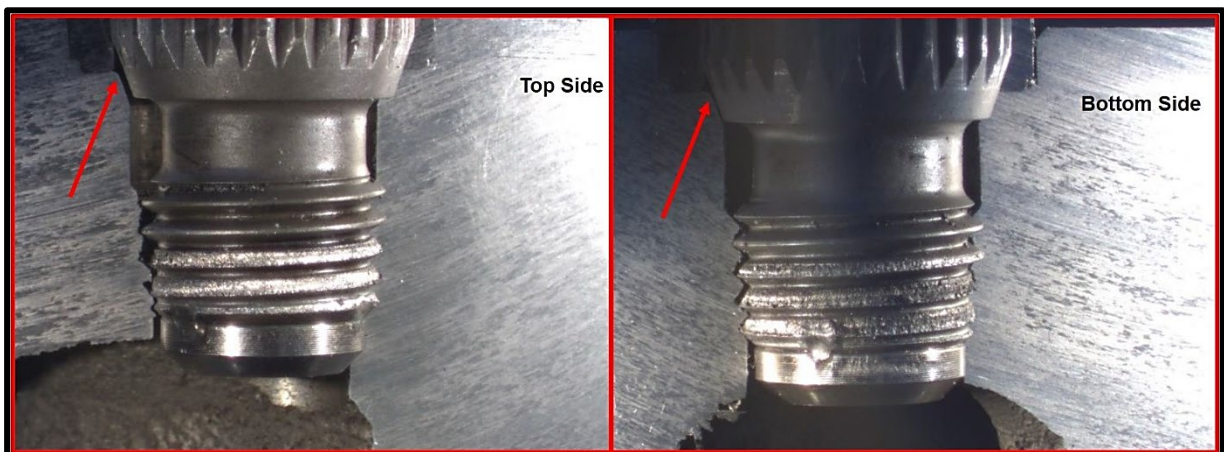
2.3.2.5. Furthermore, the oil nipple exhibited two unblended spot welds and one lightly blended weld, suggesting inconsistent rework during prior manufacture or overhaul. The conical seating surface on the nipple displayed no witness marks, confirming that the component had not properly contacted the seating surface to achieve the intended preload. Deformation of the O-ring was consistent with displacement and extrusion during operation.

Figure 5 Arrows represents NO contact with Conical Shoulder

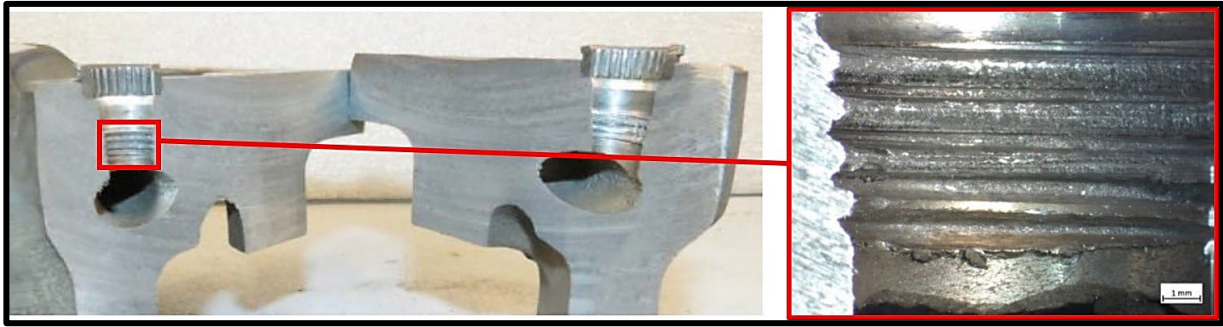
Figure 6 Axial wear on all threads

2.3.2.6. Laboratory investigation confirmed axial thread wear throughout the circumference of the threaded area. Profilometric measurements quantified the loss of material consistent with fretting fatigue induced by cyclic vibration. Simulated assembly trials demonstrated that when a short-depth thread (13 mm) was combined with a weld-reworked nipple, full torque preload could not be achieved.

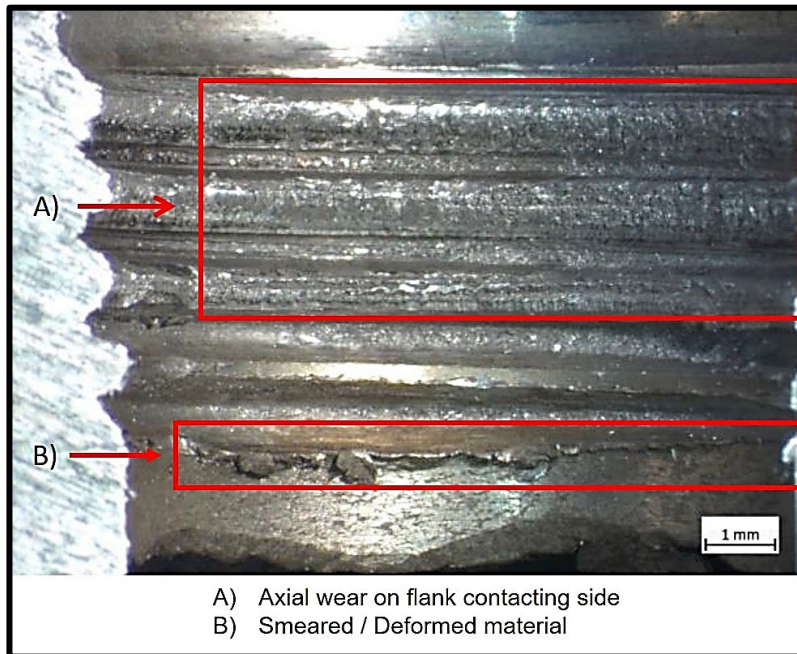
Figure 7 Axial wear on all threads and deformed material

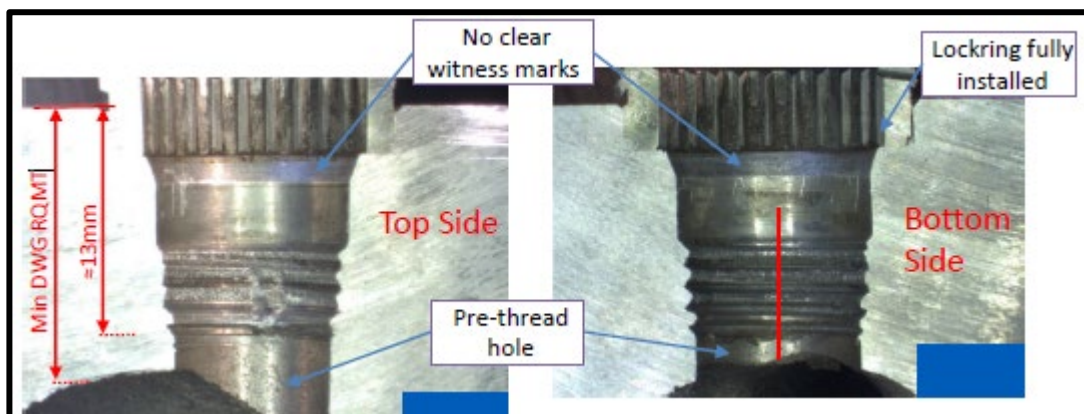
2.3.2.4. Measurement of the AGB housing thread depth showed a non-conforming depth of approximately 13 millimetres, whereas the engineering drawing specified a minimum of 16 millimetres.

Figure 8 Non-conforming thread depth

- 3.1.8. The **thread engagement depth was below design tolerance** (13 mm vs 16 mm), reducing the axial retention capability of the nipple.
- 3.1.9. The **weld rework irregularities on the nipple created uneven surfaces**, preventing the nipple from achieving full torque preload.

4.1.1.1. **Mandatory Inspection and Corrective Action.** Issue a Service Bulletin prescribing detailed inspection of GE90 AGB housings and oil-nipple assemblies for thread depth, weld condition, and axial wear, and mandating repair or replacement for any non-conforming units.
