FINAL INVESTIGATION REPORT

SERIOUS INCIDENT (ENGINE FAILURE ON GROUND)

**M/S SKY WINGS PIPER 34-200T AIRCRAFT
REG. NO. AP-BOG AT JIAP, KARACHI ON 23-05-2025**

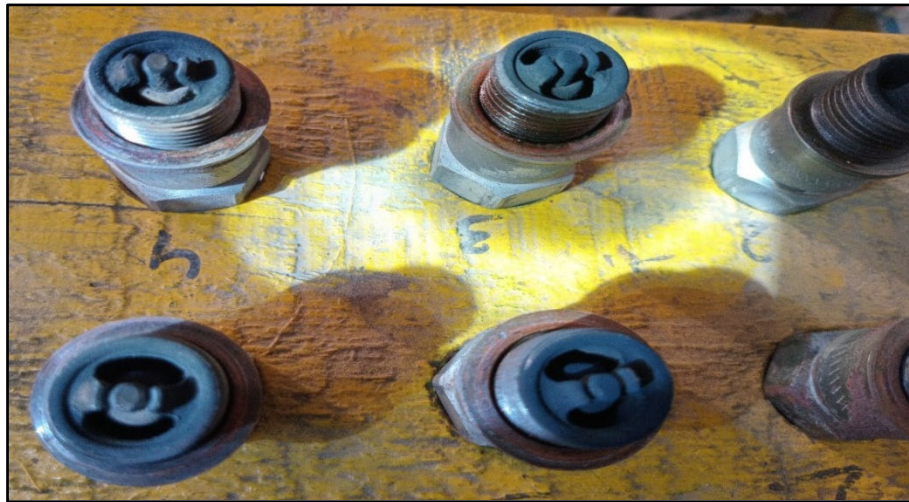
- (a) Heavy carbon deposits observed on electrodes of left engine spark plugs. The right engine's spark plugs showed minimal carbon deposits.

Figure 3 Heavy carbon deposits observed on electrodes

4.1.1.3. Implement a recurring maintenance inspection program for spark plugs, focusing on electrode condition, gap measurement, corrosion, and oil fouling.

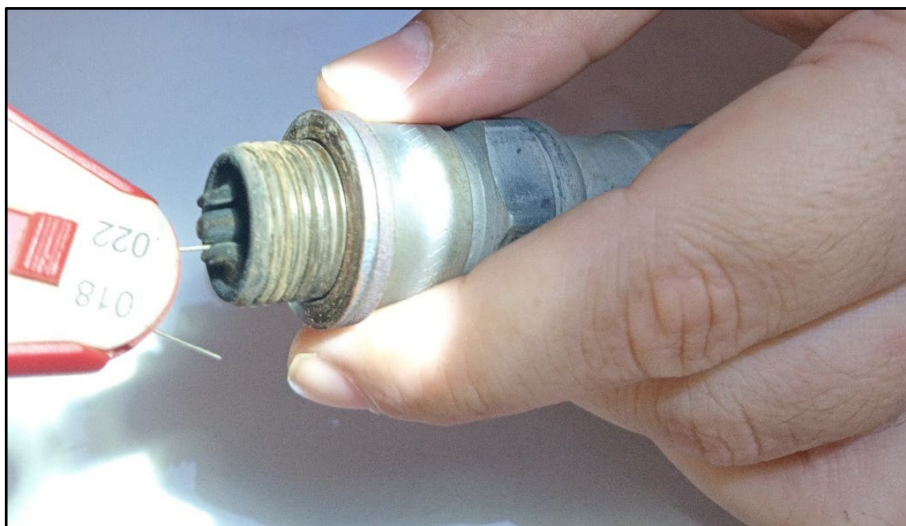
- (b) Gaps between electrodes of the left engine spark plugs exceeded Original Equipment Manufacturer (OEM) specified limits i.e. specified value is 0.16 – 0.21 millimetres (mm) and were found to be more than 0.22 mm. Same was observed in spark plugs of right engine.

Figure 4 Gaps exceeding OEM-specified limits

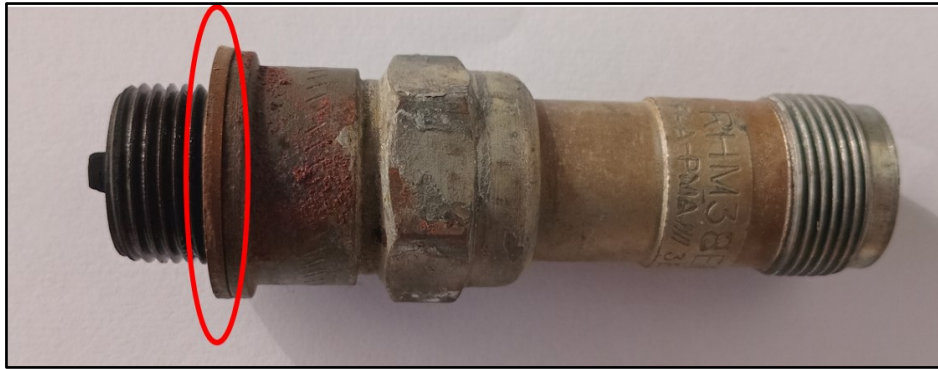
- (c) According to OEM manuals, spark plugs must be thoroughly cleaned with the specified cleaner and adjustment as per specified values. Copper Gaskets installed with spark plugs are corroded (**Appendix “D”**) and should be replaced as specified by the OEM.

Figure 5 Copper Gaskets installed with spark plugs are corroded

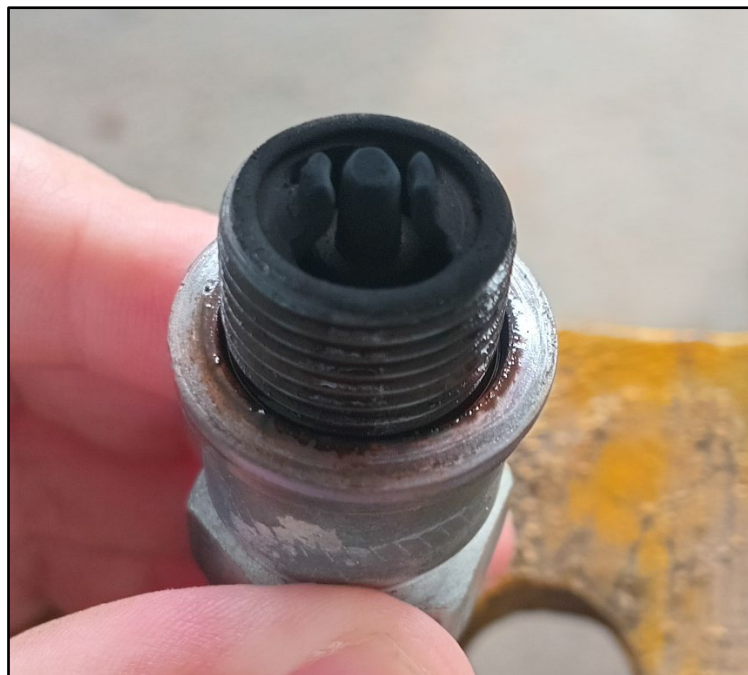
- (d) Oil deposits were also observed on the electrode ends of the spark plugs.

Figure 6 Oil deposits observed on the electrode ends

2.4.5.3. The presence of oil on the spark plugs is consistent with plug fouling, which can prevent adequate spark generation and lead to failure to start, especially after a hot or abnormal shutdown. The condition of the spark plugs was assessed as pre-existing and not directly caused by the feathering check. This degraded condition, however, significantly reduced the likelihood of a successful engine restart following the abnormal shutdown.
