FINAL INVESTIGATION REPORT

SERIOUS INCIDENT (TYRE BURST & AUTO PILOT NOT DISENGAGING)

**VISION AIR FLIGHT VIS-1105, BOEING 737-3B3(QC) AIRCRAFT,
REGISTRATION NO. AP-BMU AT ALLAMA IQBAL INTERNATIONAL
AIRPORT LAHORE ON 11TH APRIL, 2018**

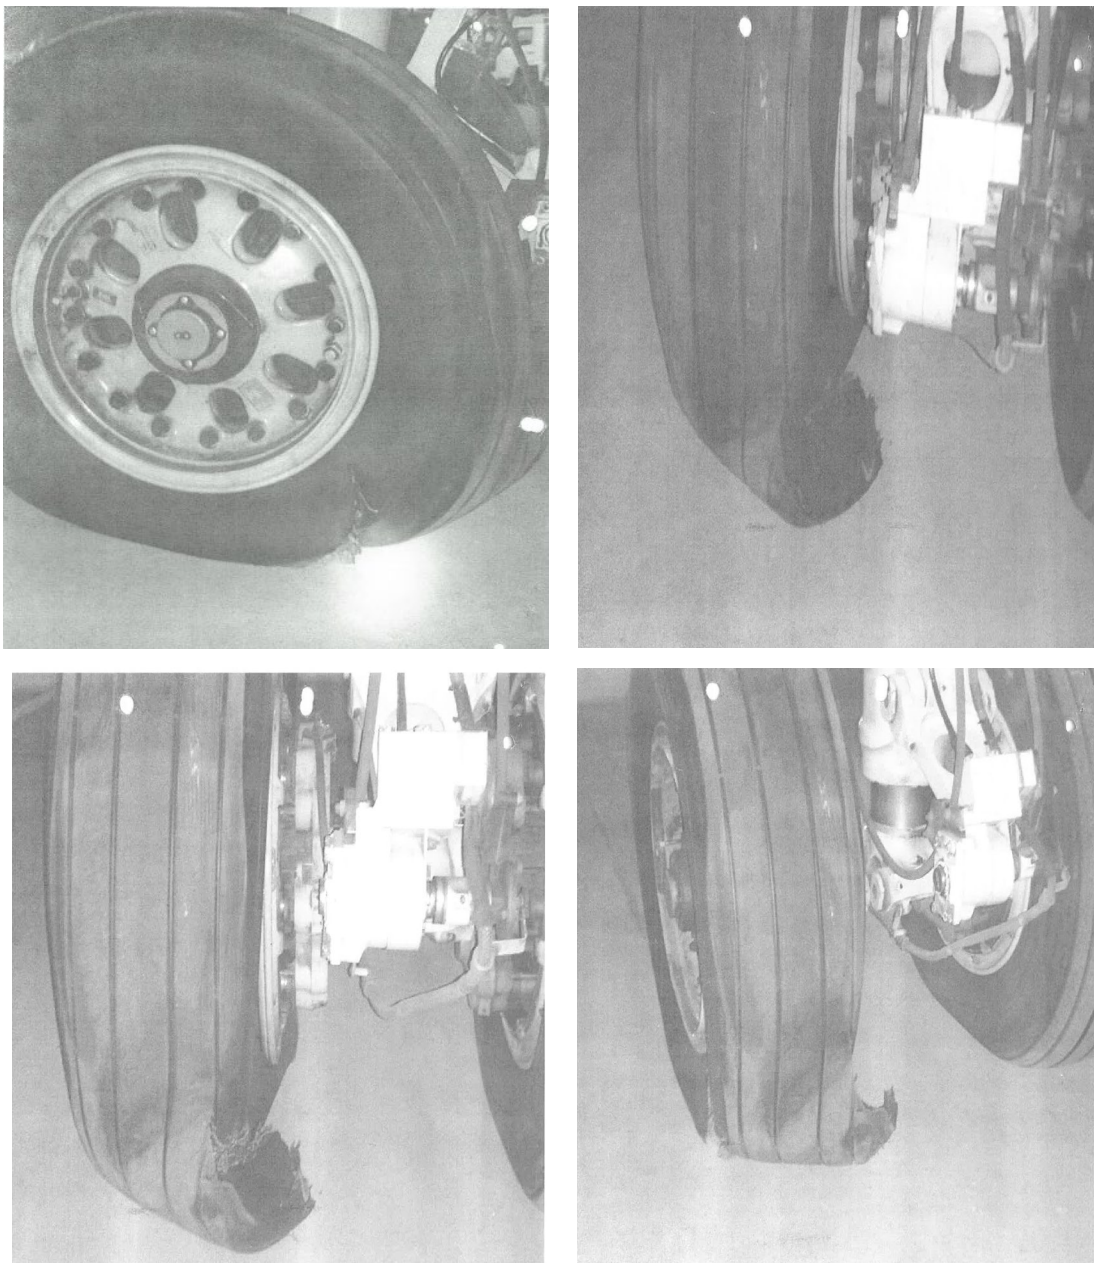
1.3.1. Left inner tyre was found burst.

Figure 1 Left Tyre Burst

2.9.1 After shutting down the aircraft, the Captain asked the Flight Engineer to inspect the tyres for any anomaly. Meanwhile the tower informed that one of the tyres had burst and that some tyre pieces had been found on the R/W. Inspection revealed that the left inner tyre had ruptured.

2.10.2 **Anti-skid system:** An Anti-skid System Diagnostic Test was performed as per the AMM and there was no defect found in the anti-skid system which might have caused the tyre to jam and rupture after skidding on the R/W. No anti-skid system components were removed for evaluation and no wiring checks were performed. Also, all the other tyres were in good condition without any evidence of wearing out or skidding. Moreover, the tyre was ruptured from one side rather than the center indicating that the tyre burst was likely not due to the anti-skid malfunction.

2.10.4 **Tyre condition:** The affected tyre was a new tyre which also precludes the possibility that the tyre burst occurred because of worn out condition or excessive use.

- 3.2.1. The exact cause of occurrence could not be determined, however, the rupture of the tyre may have been caused by the presence of FOD on the RW once the aircraft landed.
