## BUREAU OF AIRCRAFT SAFETY INVESTIGATION PAKISTAN

### FINAL INVESTIGATION REPORT

### SMOKE FROM LANDING GEAR

| Aircraft Type | Airbus A330-343 |

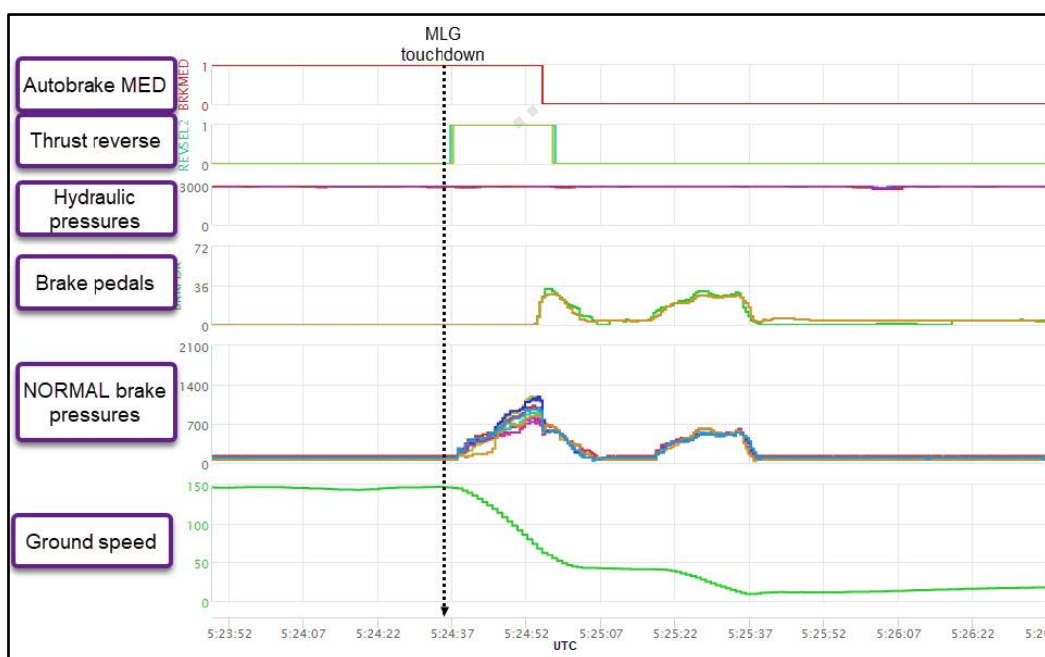
*Figure 1 Plot of the Braking Parameters during the Landing Phase*

1.11.2. The DFDR data showed that during Approach and Landing, all hydraulic systems (Green, Blue, and Yellow) were operating at approximately 3000 psi. Braking parameters during landing and taxi were recorded in the DFDR.

1.11.3. After the aircraft vacated the R/W and the park brake was applied, alternate brake pressure was recorded to increase and stabilize. **Subsequently, a reduction in alternate brake pressure was recorded, followed by a progressive decrease in Blue hydraulic system pressure to zero.**

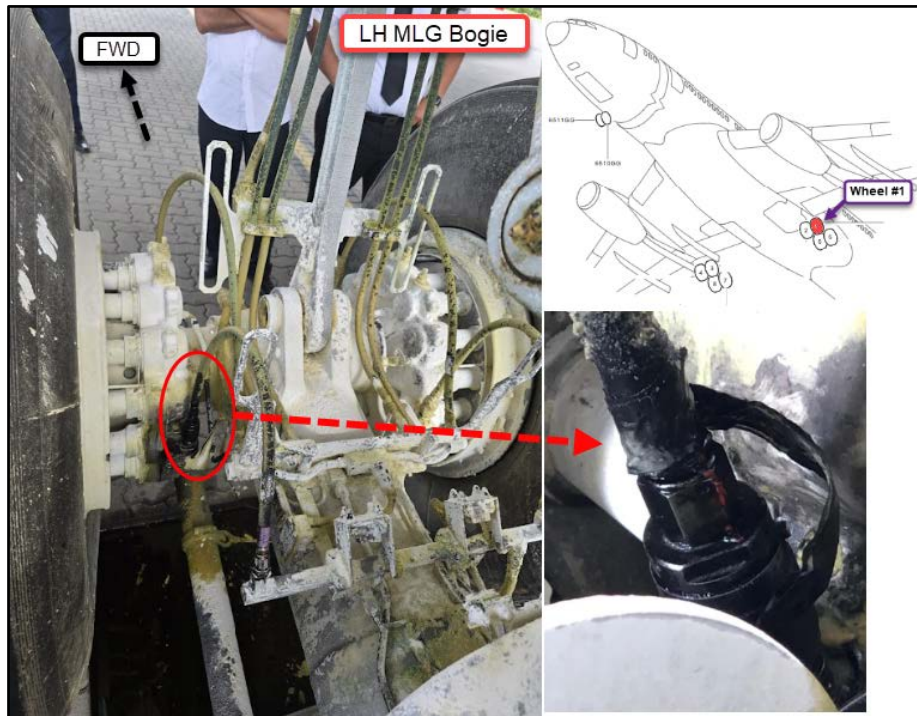
*Figure 2 Tape on the Brake Hose*

1.16.6. Photographic evidence showed the presence of tape applied to the hose prior to the occurrence. The tape was not part of the original hose configuration.

2.3.4.3. **The presence of tape on the brake hose prior to the occurrence is consistent with the possibility that the affected area had been previously identified or subjected to temporary rectification.** This suggests that the damage to the hose was

not entirely sudden but had developed over a period of time. Permissible damage and defects on hydraulic hoses are specified in AMM 20-23-11-200-802-A-permitted damage and effects on hydraulic hoses.

2.4.5.1 The examination of the hose was unable to determine when crack initiation started however, the presence of the tape indicates that the damage must be present to the hose prior to the flight and must have been noted by the maintenance personnel in order to have been covered by tape.

| 4.1.1.2. Maintenance actions are formally recorded and followed in accordance with approved maintenance procedures | |
|---|---|
| <b>Recommendation</b> | Ensure that any temporary maintenance actions (e.g., protective coverings or tape) are formally recorded, tracked, and followed by permanent rectification in accordance with approved maintenance procedures. |

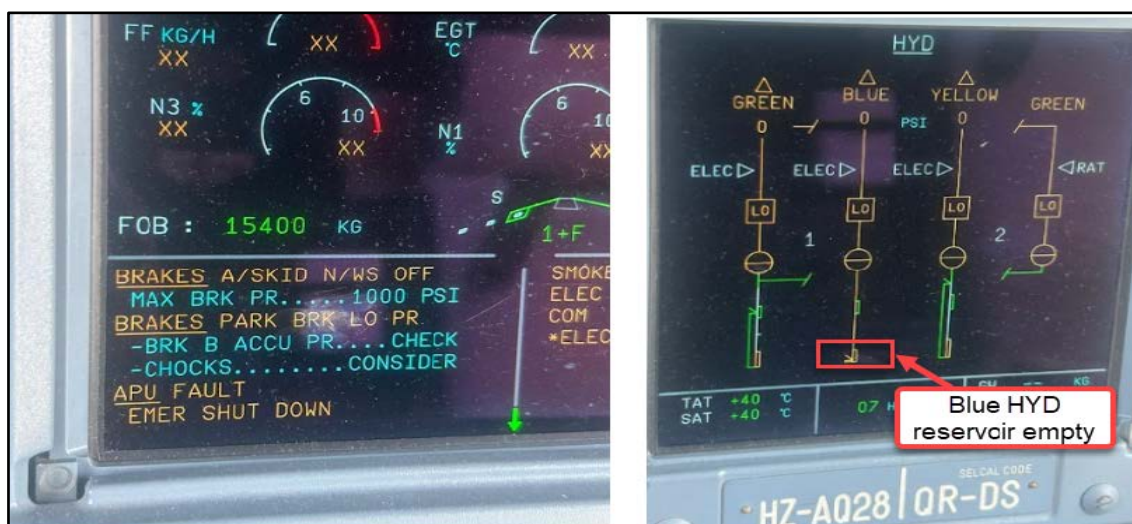
Figure 4 Post Event ECAM Hydraulic SD page

2.3.1.2. The rupture of the brake hose resulted in a continuous leakage of hydraulic fluid from the Blue hydraulic system. Due to the sustained nature of the leak, the system reservoir progressively depleted, leading to a reduction in available hydraulic pressure. As the pressure decreased, the effectiveness of the braking system degraded, ultimately resulting in the loss of braking capability and unintended forward movement of the aircraft.

2.3.1.3. The recorded leak rate of approximately 8–10 liters per minute was below the activation threshold of the hydraulic system safety valve. **Consequently, the system did not isolate the leak, allowing continuous fluid loss and eventual depletion of the Blue hydraulic reservoir.**
