FINAL INVESTIGATION REPORT

SERIOUS INCIDENT TCAS-RA

**SAUDIA AIRLINE FLIGHT SVA722 BOEING 777-300ER
AIRCRAFT REG. NO. HZ-AK32 (OEJN TO OPIS) AND
MILITARY AIRCRAFT ON 14-03-2022**

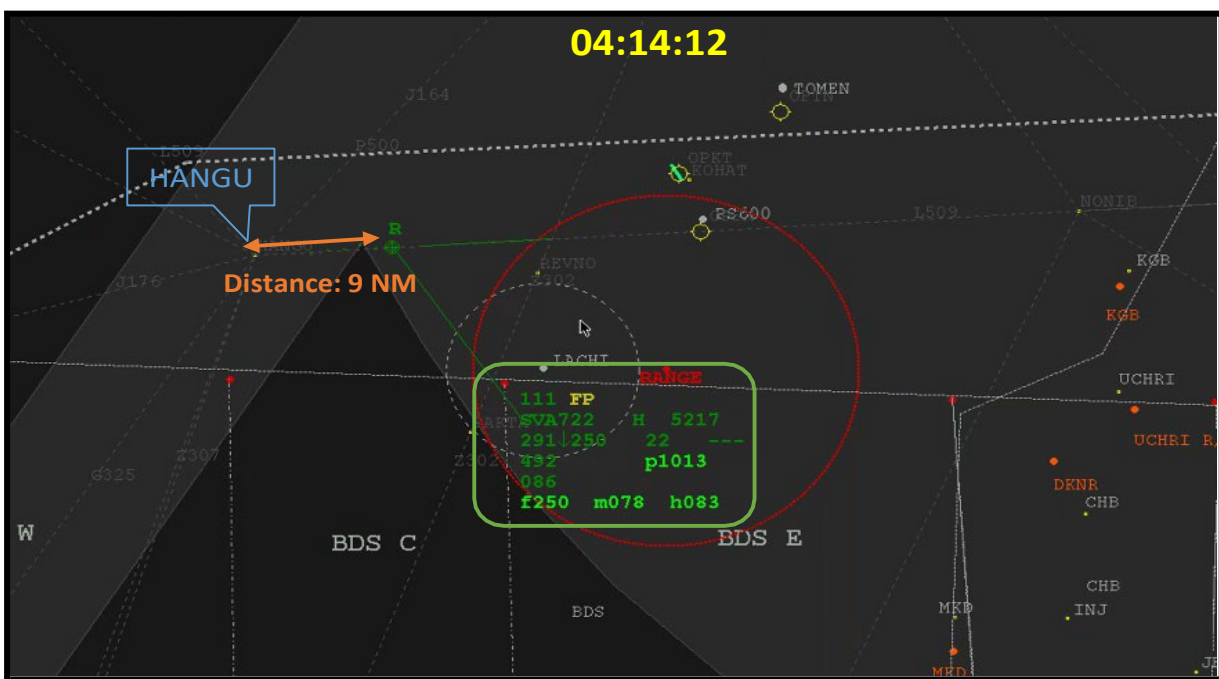
Figure 5 SVA722 instructed to turn right heading 110°

1.1.6. **04:14:12** To facilitate an unrestricted descent due departing traffic from OPIS, Islamabad, SVA722 was instructed to turn right onto heading 110°, approximately 9 NM East of HANGU on route J139, and was re-cleared to descend to FL210.

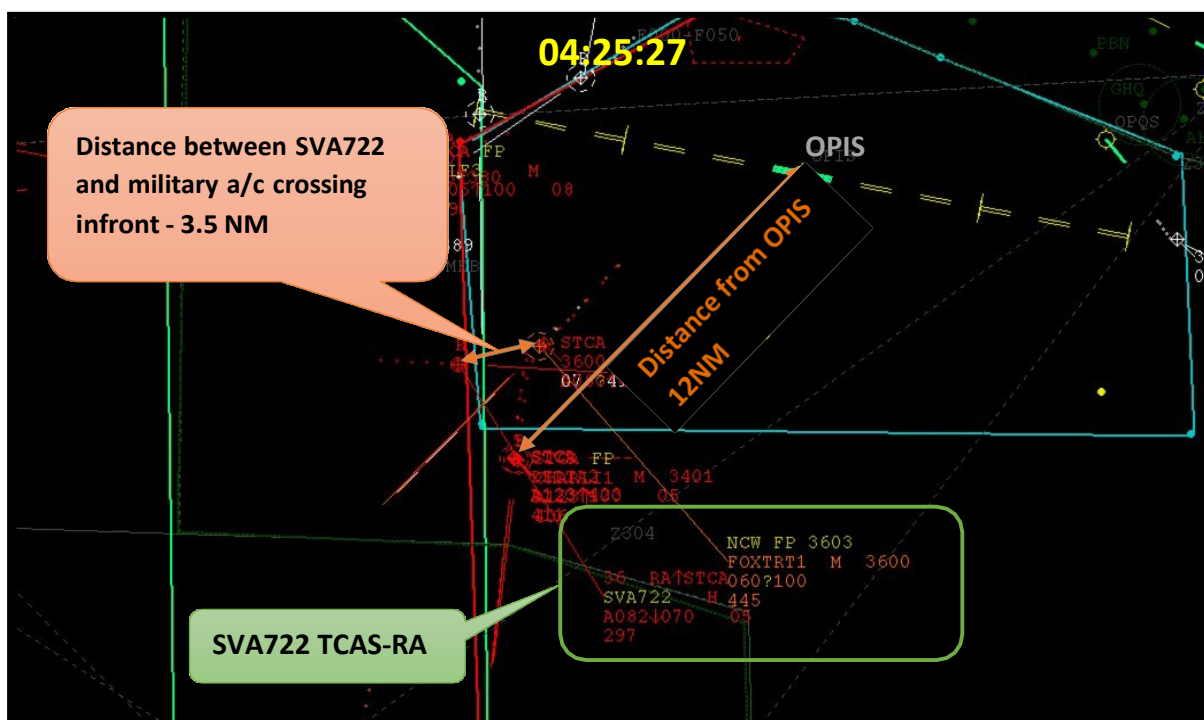
Figure 10 TCAS-RA SVA722

1.1.13. **04:25:27** At 12 NM South-West of OPIS, abeam position SUMEB, radar display indicated SVA722 encountering an STCA followed by TCAS-RA. At this time, SVA722 was passing 8,200 ft for 7,000 ft with a descent rate of approximately 500 ft/min. The conflicting military formation crossing ahead of SVA722, at a distance of approximately 3.5 NM, consisted of four military aircraft, two of which were observed climbing and passing 7,800 ft and 7,700 ft, thereby reducing the vertical separation. The military aircraft were climbing to 10,000 ft on recovery from fly past area to Mianwali, OPMI.

2.1.1.2 SVA722's vertical profile shows a continuous descent, passing 8,200 ft for 7,000 ft when the Short-Term Conflict Alert (STCA) and subsequent TCAS-RA were triggered. This positioned the aircraft within the altitude band assigned to the recovering military formation (FL080 and above), increasing the potential for conflict. A proactive strategy to manage SVA722's routing and descent clearances, with the objective of keeping the civil aircraft clear of recovering military traffic, would have increased vertical separation margins and reduced the likelihood of conflict during the recovery phase.

2.1.2.1 Radar data shows that the military formation initially crossed ahead of SVA722 with 3.5 NM lateral spacing, later reducing to 1.7 NM as the aircraft continued climbing. Simultaneously, one aircraft in the formation was observed crossing through 8,200 ft, momentarily occupying the same level as SVA722, which was descending through that altitude. This combination of narrowing lateral spacing and loss of vertical separation triggered the STCA, followed by the TCAS-RA onboard SVA722.

3.1.7 Radar data indicated that the military formation crossed ahead of SVA722, with lateral separation reducing from approximately 3.5 NM to about 1.7 NM and one of the military aircraft was observed climbing through approximately 8,200 ft while SVA722 was descending through the same altitude, resulting in a loss of vertical separation.

3.1.8 The combination of reduced lateral spacing and loss of vertical separation led to the activation of a Short-Term Conflict Alert (STCA), followed shortly by a TCAS Resolution Advisory (RA) onboard SVA722.

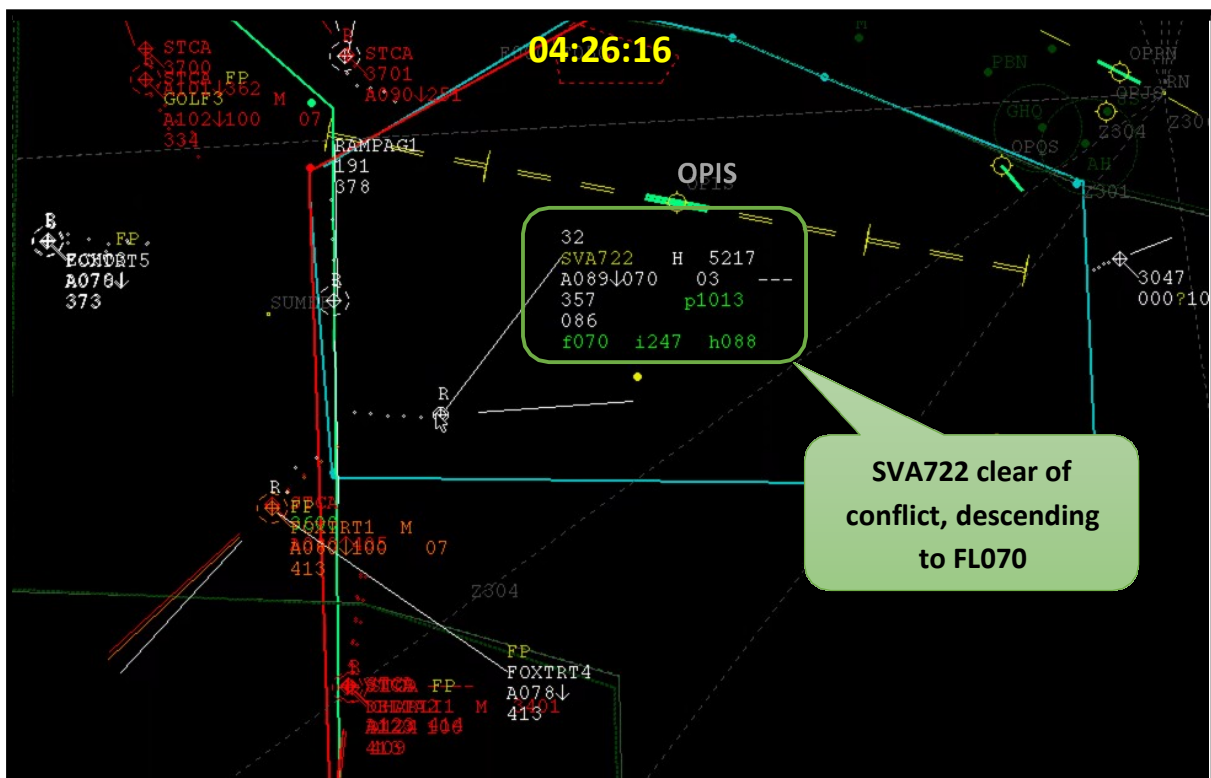
Figure 12 SVA722 clear of conflicting military aircraft

1.1.16. **04:26:16** SVA722 climbed to 8,900 ft to avoid the conflicting traffic. Once clear of traffic, the aircraft resumed its descent to 7,000 ft.

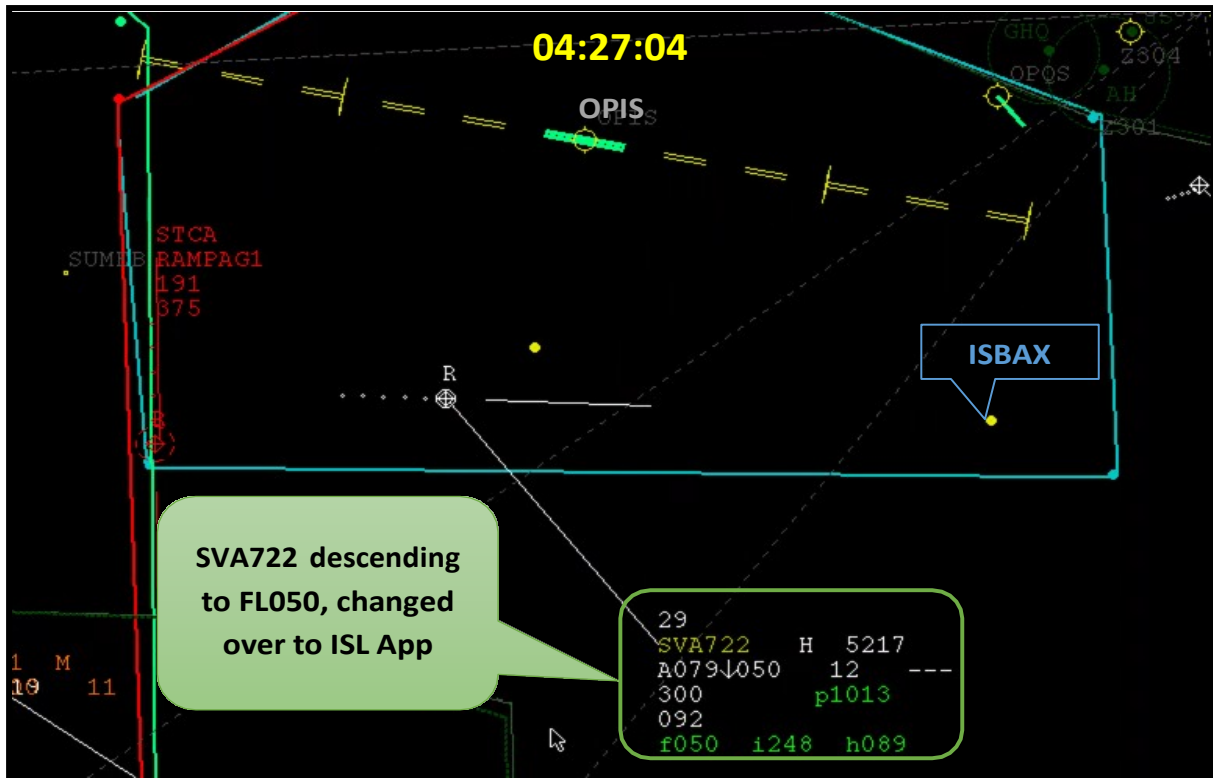
Figure 13 SVA722 changed over to Islamabad Approach

1.1.18. **04:27:04** Approximately 10 NM short of ISBAX, SVA722 was instructed to contact Islamabad Approach on frequency 121.650 MHz.

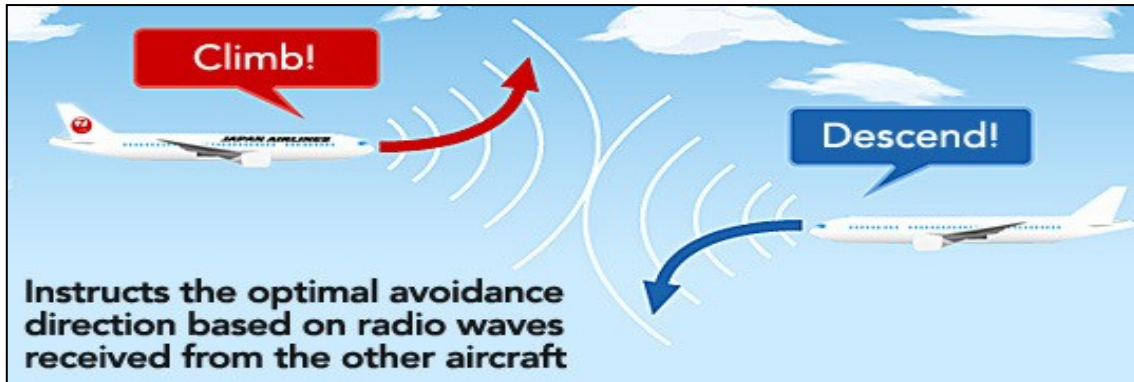
Figure 16 TCAS (RA) alert

1.18.1. **TCAS Working Principle** – TCAS stands for Traffic alert and Collision Avoidance System, and its purpose is to minimize the risk of mid-air collisions between aircraft. Working independently from Air Traffic Control, TCAS uses nearby aircraft's transponder signals to alert pilots to the danger of mid-air collisions. It does so by constructing a three-dimensional map of airspace through which the aircraft is travelling. In detecting the other aircraft's transponder signals, it can foresee the potential collisions based on speeds and altitude of planes passing through the

airspace in question. If TCAS detects a potential collision, it will automatically notify each of the affected aircraft. In this instance, it will automatically initiate a mutual avoidance manoeuvre. This involves the system informing the crews of the aircraft in question both audibly and visibly to either climb or descend in a manner that ensures that, when their paths cross, they do not meet.
