FINAL INVESTIGATION REPORT

SERIOUS INCIDENT TCAS-RA

**FLYDUBAI FLIGHT FDB325 BOEING B737-800 AIRCRAFT
REG. NO. A6-FGB (SECTOR OMDB TO OPMT) AND
MILITARY AIRCRAFT ON 12-07-2018**

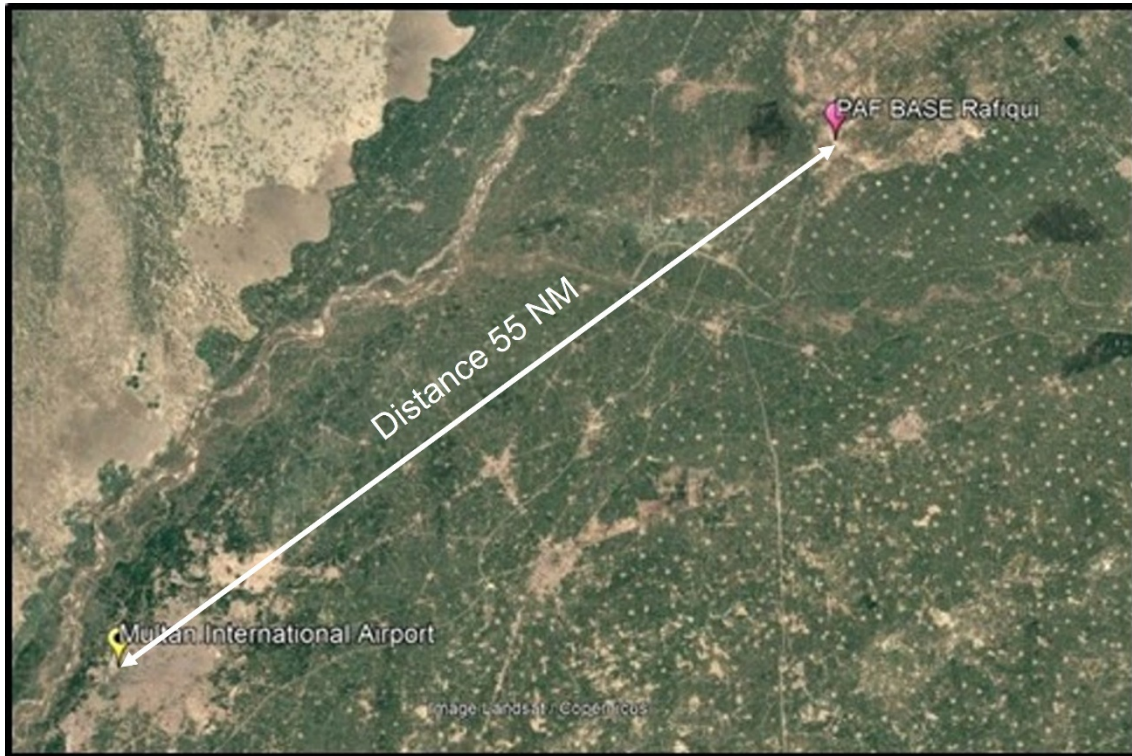
Figure 2 Distance between OPMT and OPRQ

1.1.3. PAF Base Rafiqui (OPRQ), is a Pakistan Air Force base located within the outskirts of Shorkot city in the Jhang District of Pakistan's Punjab province and North-East of Multan by 55 NM.

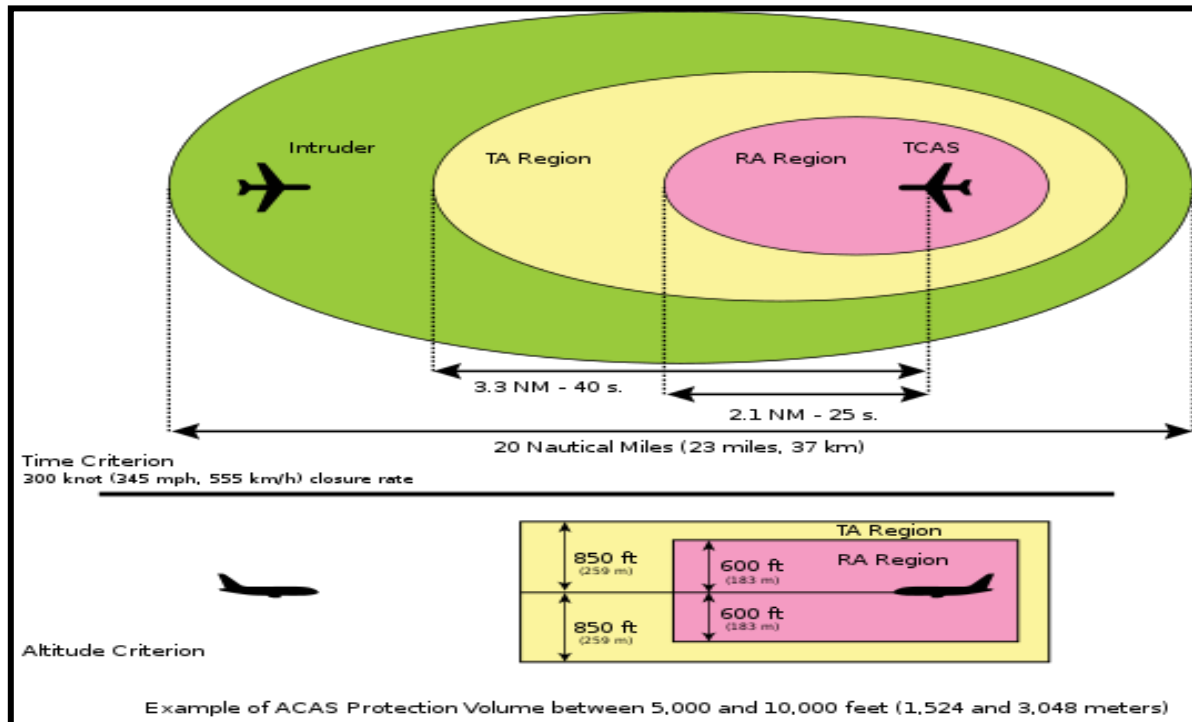
Figure 7 TCAS TA & RA ranges

1.18.2.1. The objective of ACAS is to provide advice to pilots for the purpose of avoiding potential collisions. This is achieved through Resolution Advisories (RAs), which recommend actions (including manoeuvres), and through Traffic Advisories (TAs), which are intended to prompt visual acquisition and to act as a precursor to RAs.

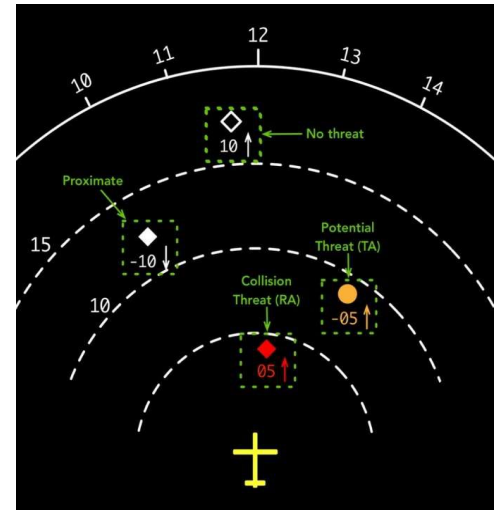
Figure 8 Traffic Display

1.18.3.4. Solid yellow or amber circle – for intruders (i.e. aircraft which trigger a TA).

1.18.3.5. Solid red square – for threats (i.e. aircraft which trigger an RA).
